Diving Service

- Marine Contractors

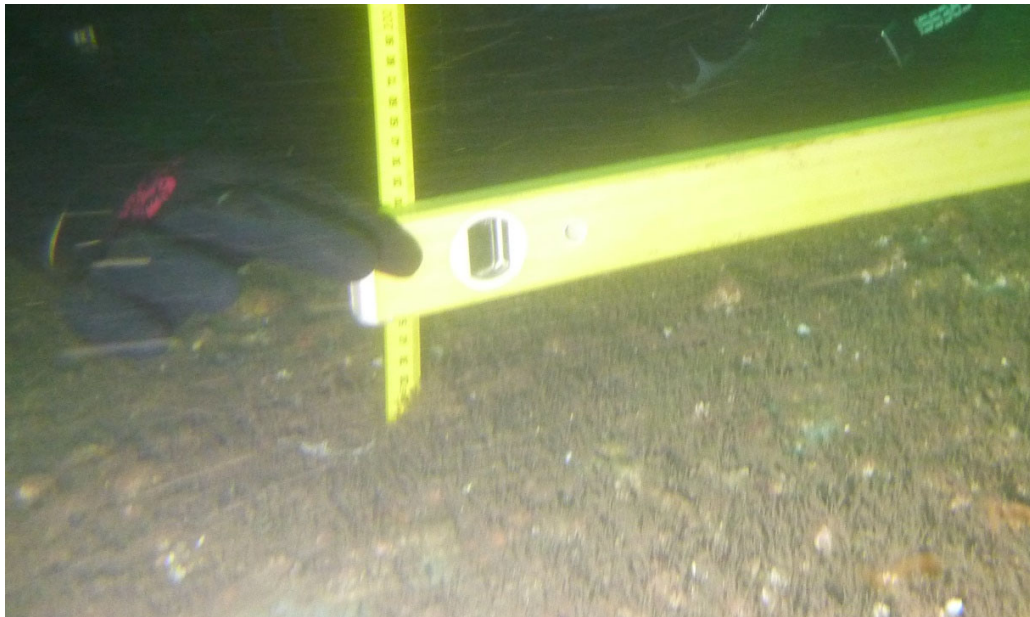
Figure 5: The list was checked by using a level and ruler on the hanger deck. No change was found in the usual list of 4 degrees to port

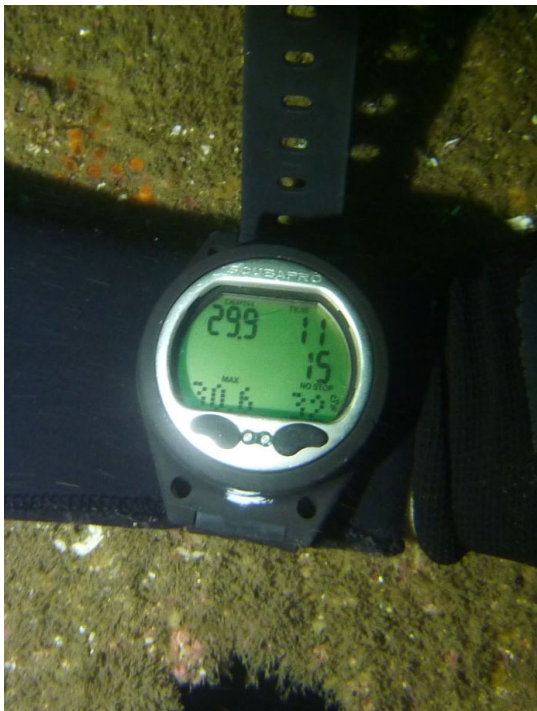
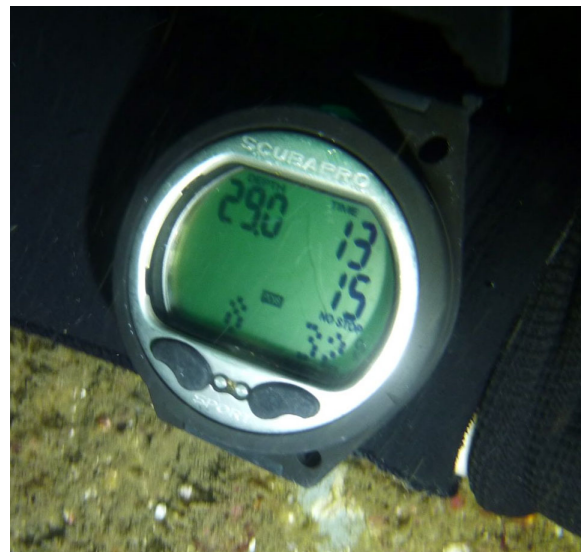
The list was also checked by placing a depth gauge on opposite gunwales amidships.

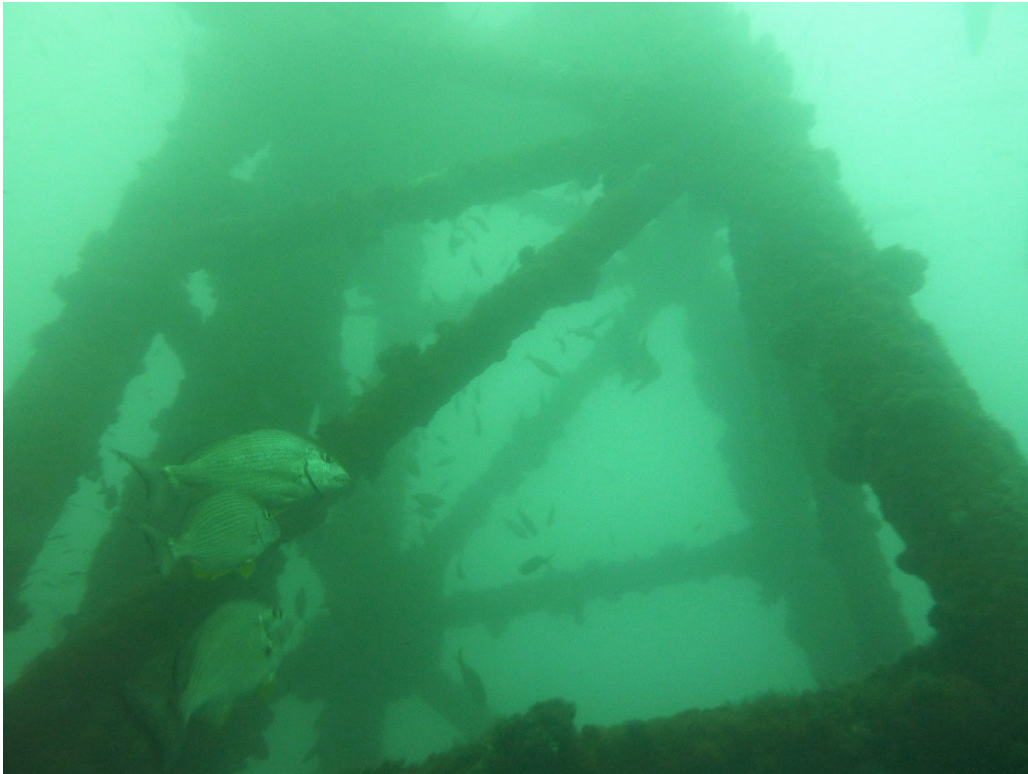
Figure 13: The Main mast is fully intact and shows no sign of wear.

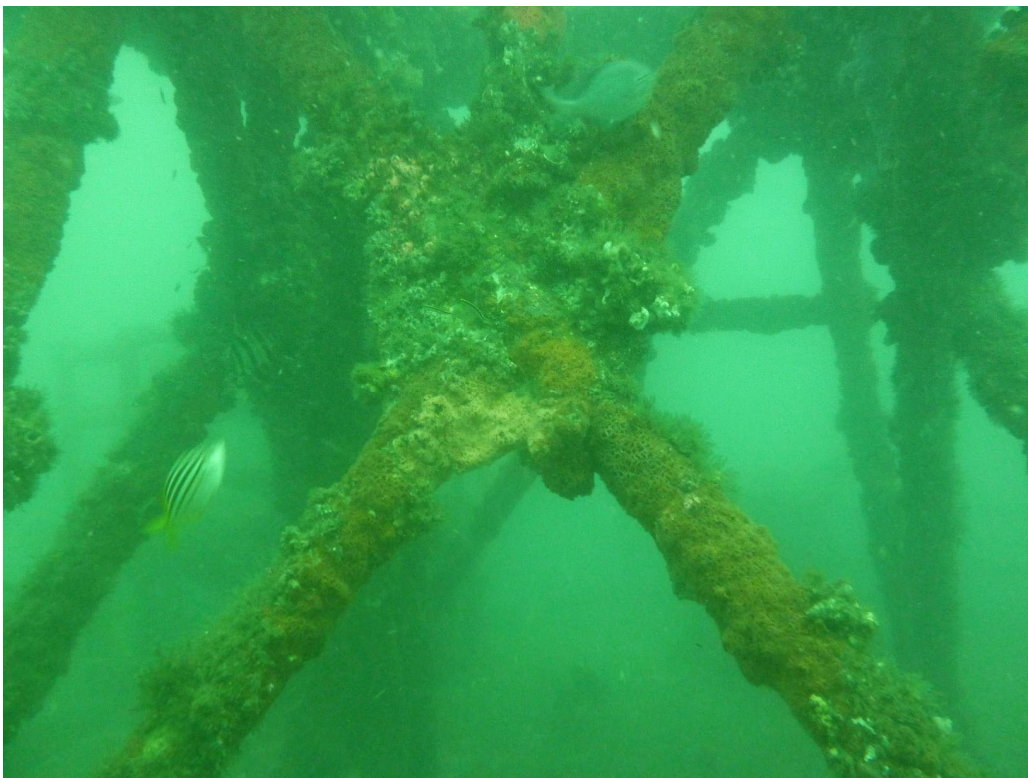
Figure 14: A close-up of the strut of the main mast. It is fully encrusted with marine growth and no sign of corrosion or cracking.

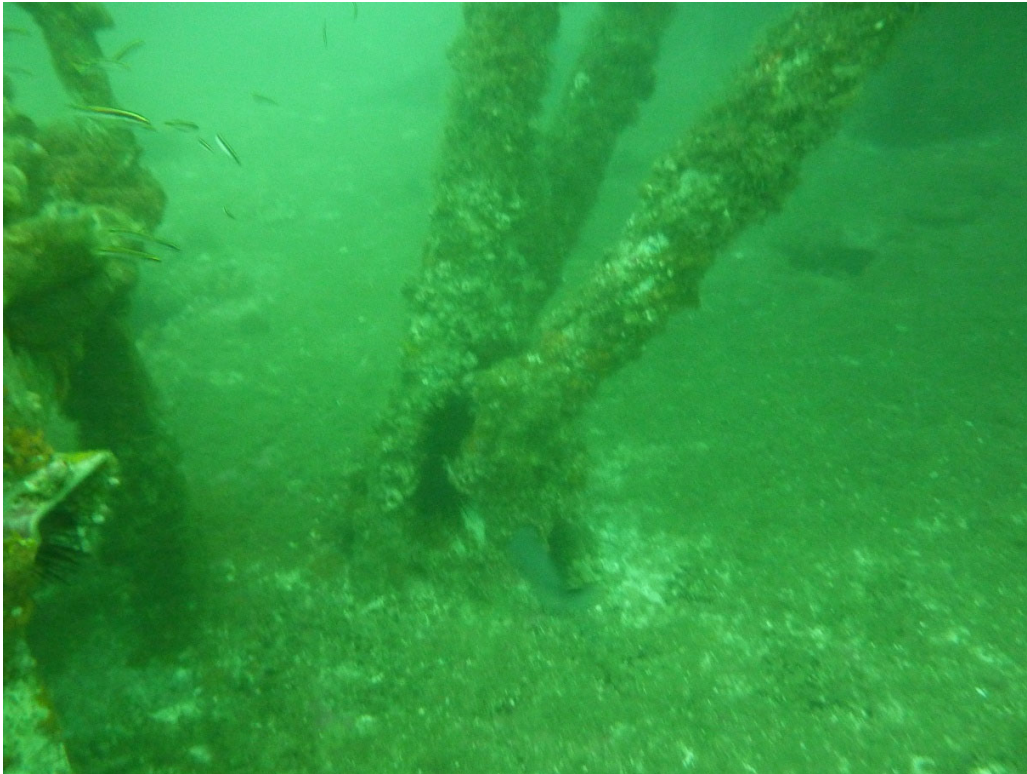
Figure 15: A view of one of the main mast legs showing a sound connection to the superstructure.
