To Martin Dawson  
Department of Crown Lands

From Alan McLennan  
Project Manager

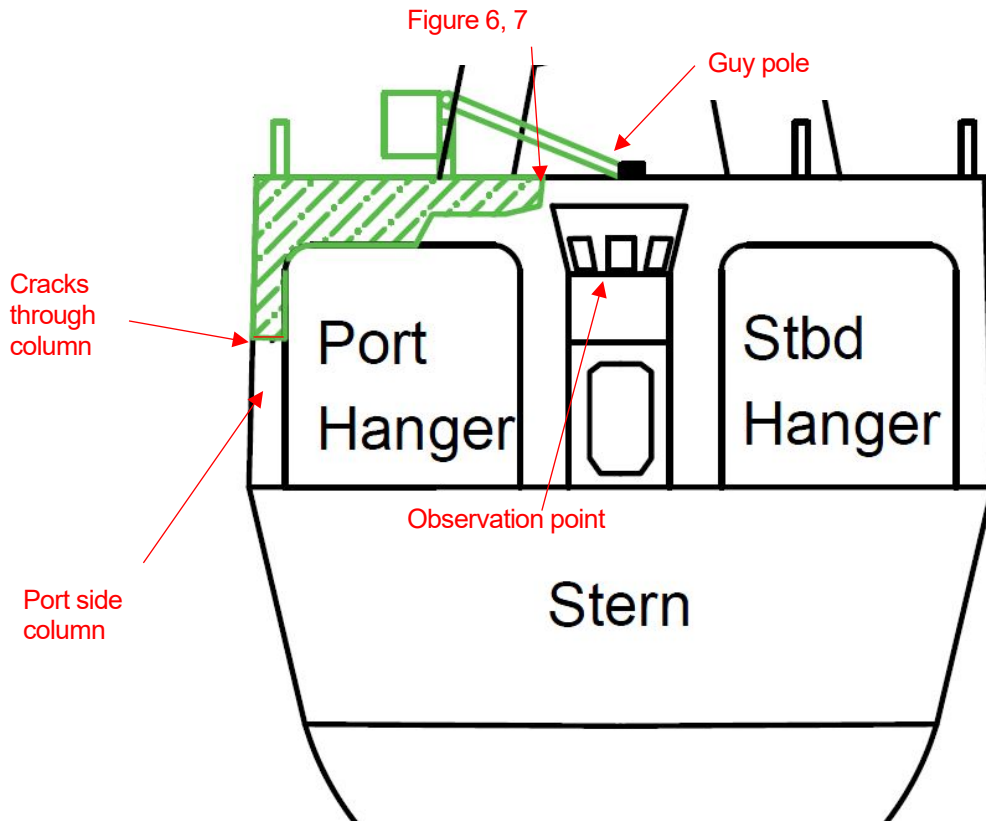
Figure 1: Stern view of the vessel showing the broken rear hanger frame in green.

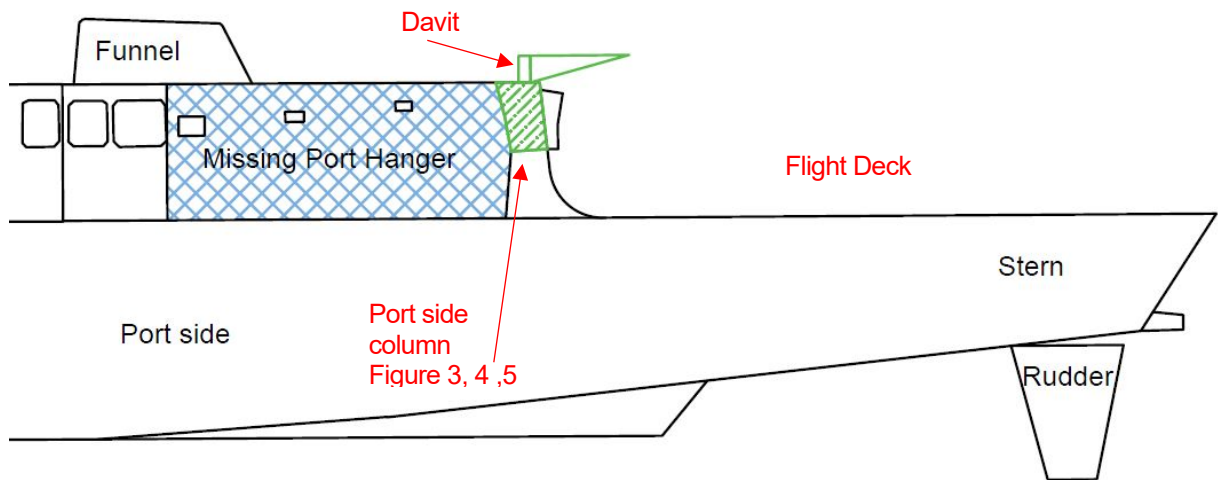
Figure 2: Port side view of the vessel showing port side column in green

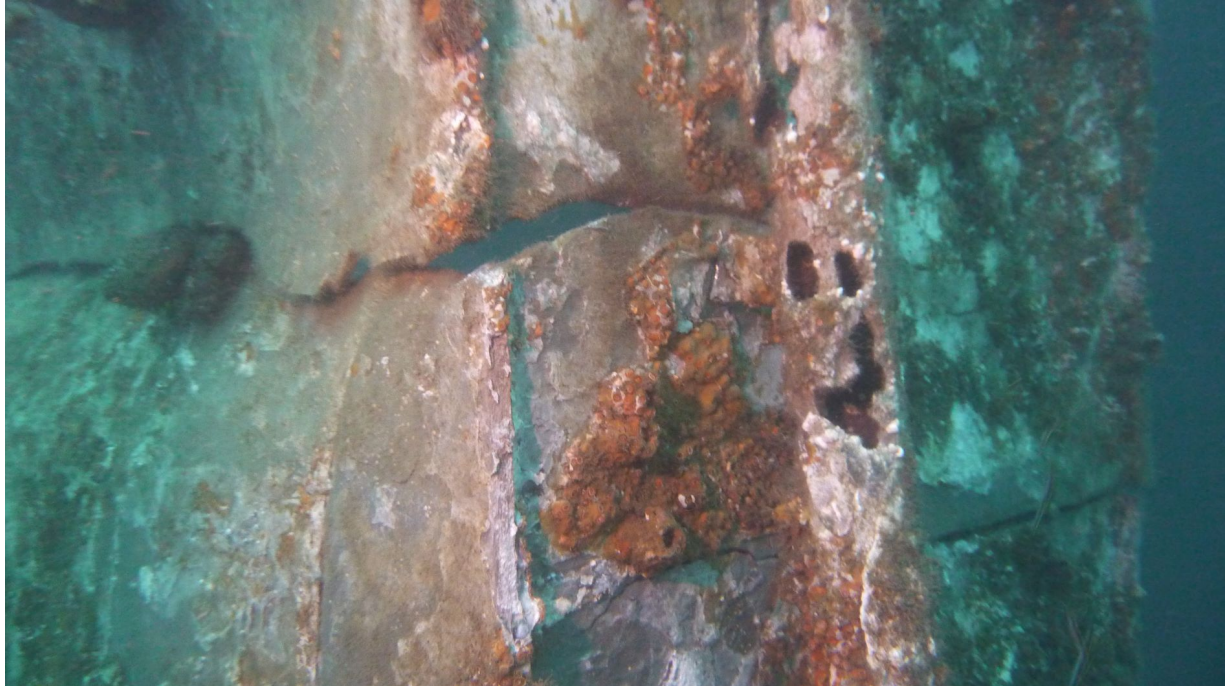
**Figure 5: A view of the corner of the port side column. This shows the same cracks as in Figures 1 and 2**

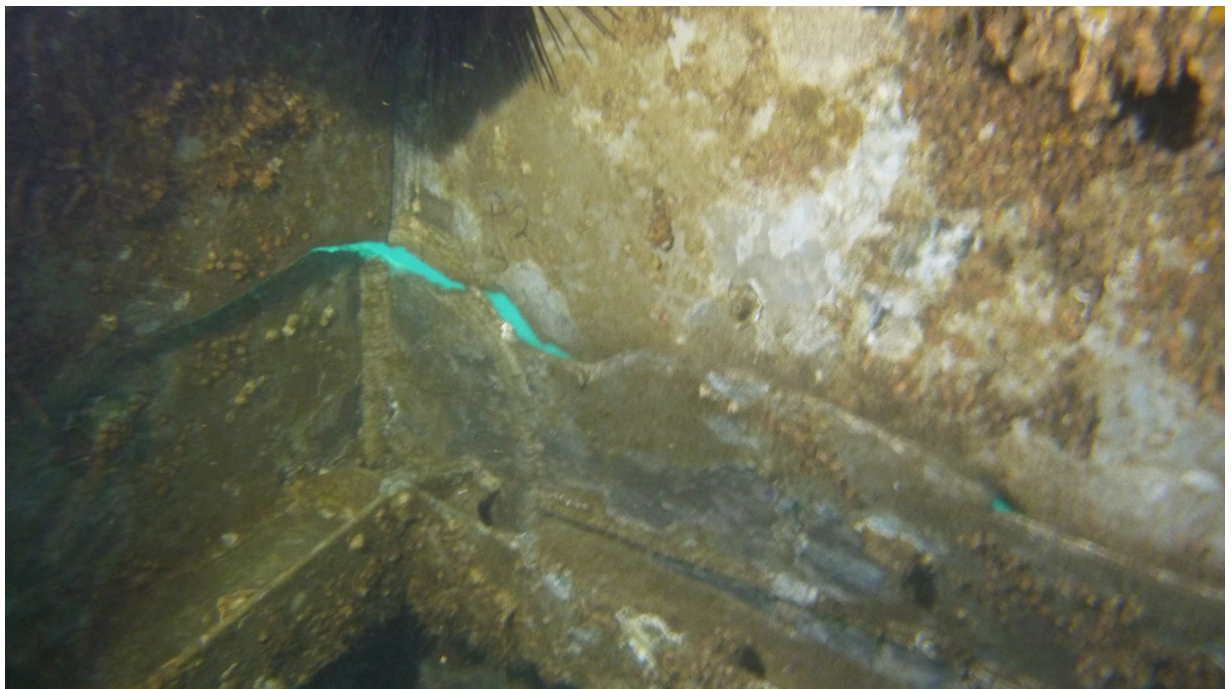
**Figure 6: This view shows the cracks through the port side column from the inside**

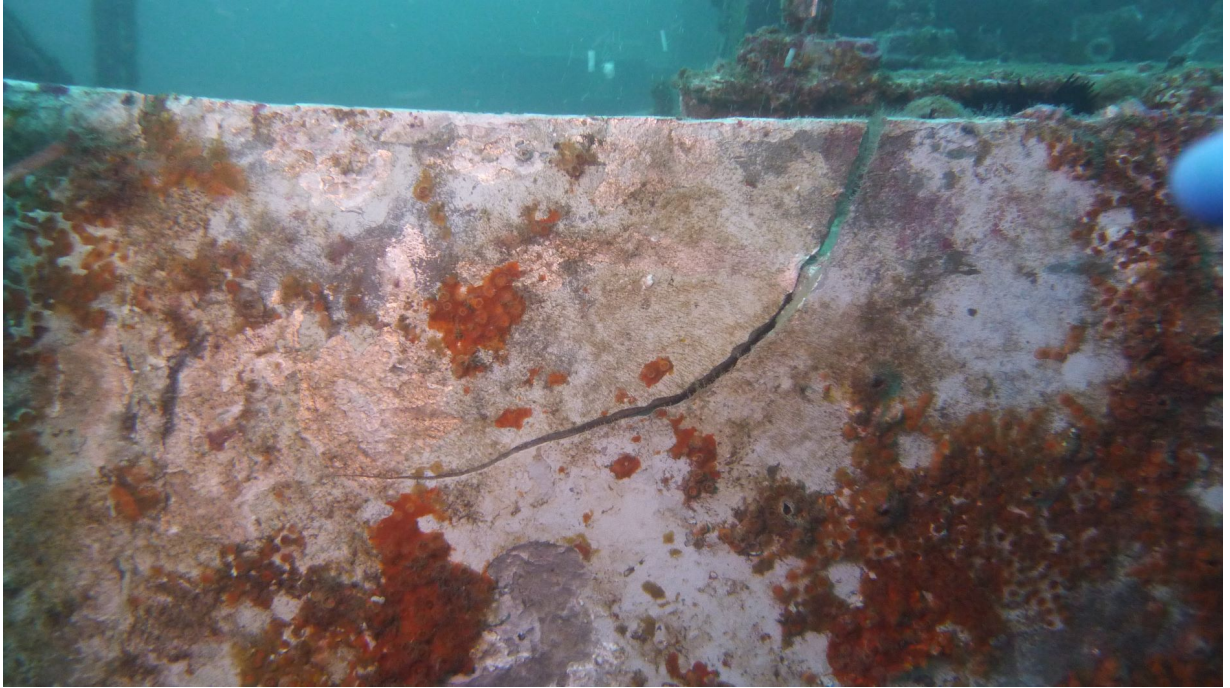
**Figure 7: This is the break through the aft face of the hanger wall above the hanger door.**

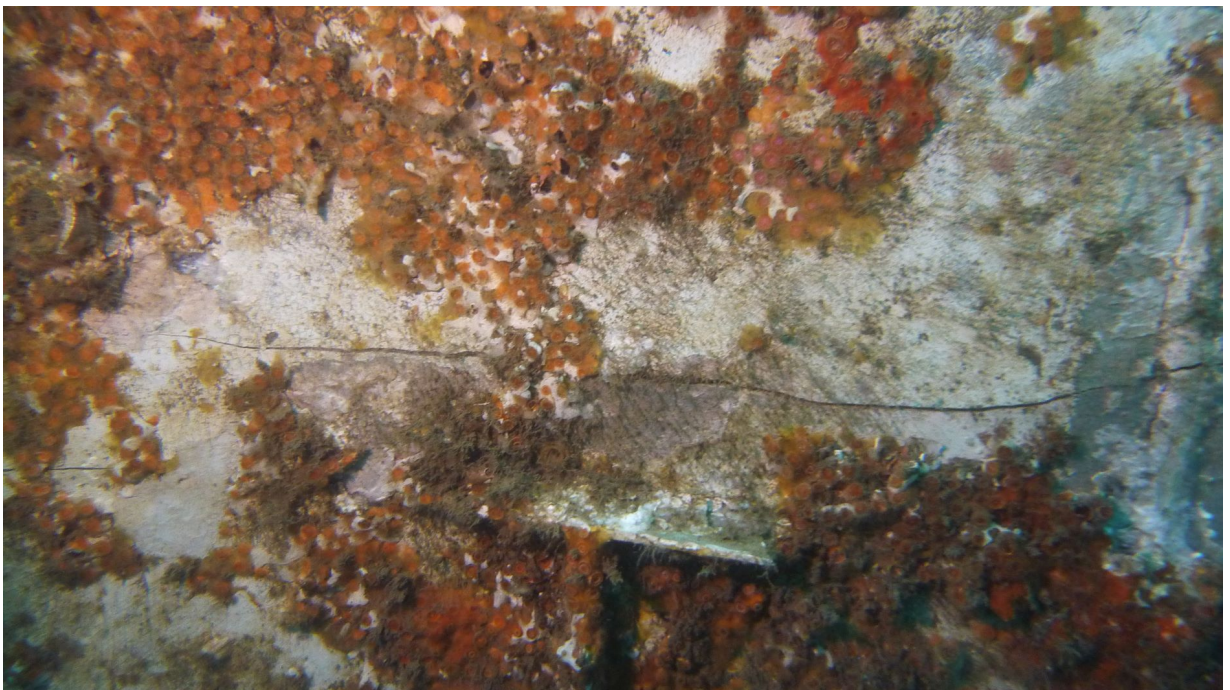
**Figure 8: This is the same crack shown above but shows it travelling along the aft wall**

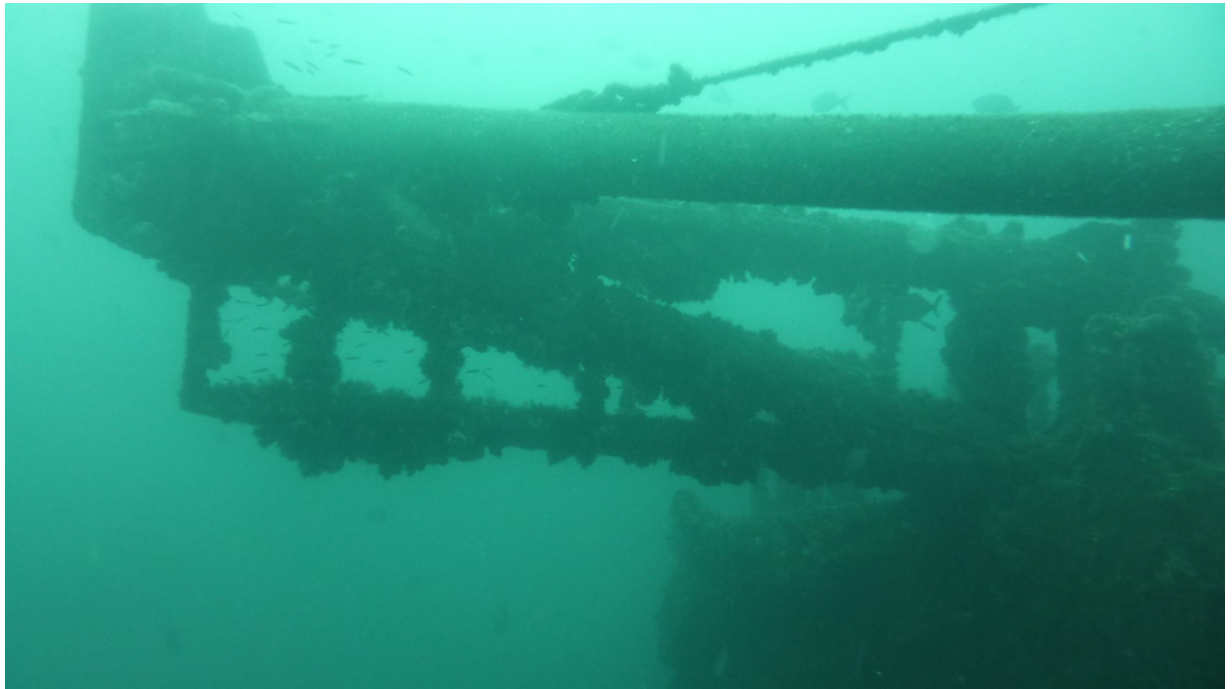
**Figure 9: A view of the davit projecting over the port side flight deck**

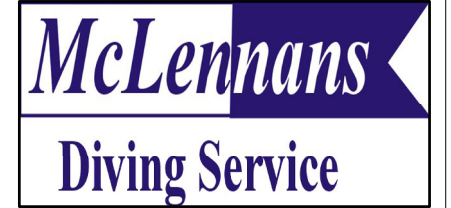
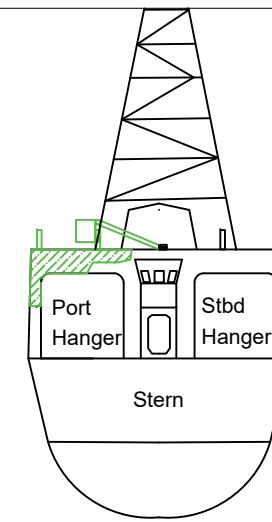
ex HMAS Adelaide  
Stern View  
Showing Part A

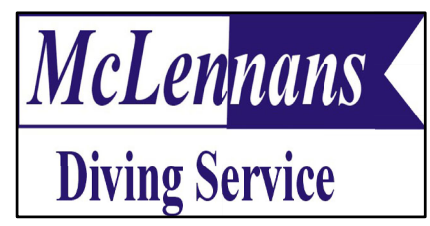
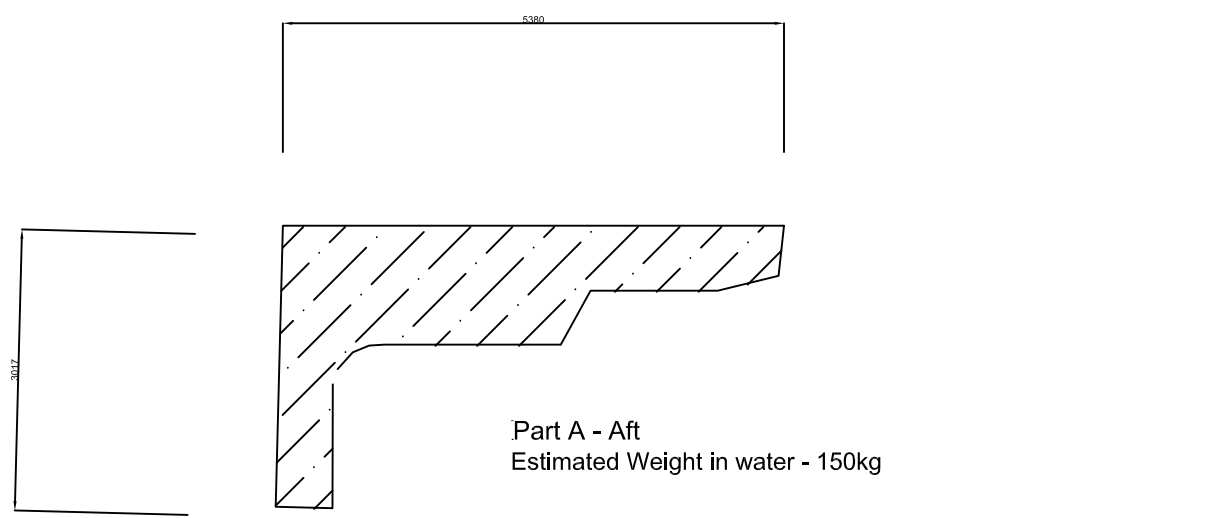
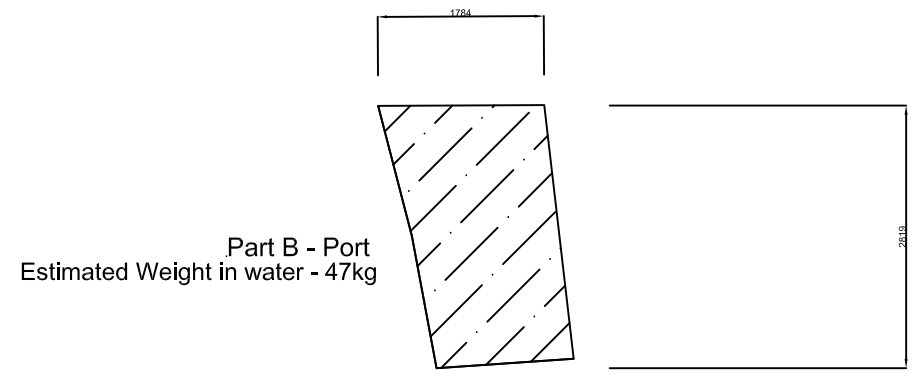
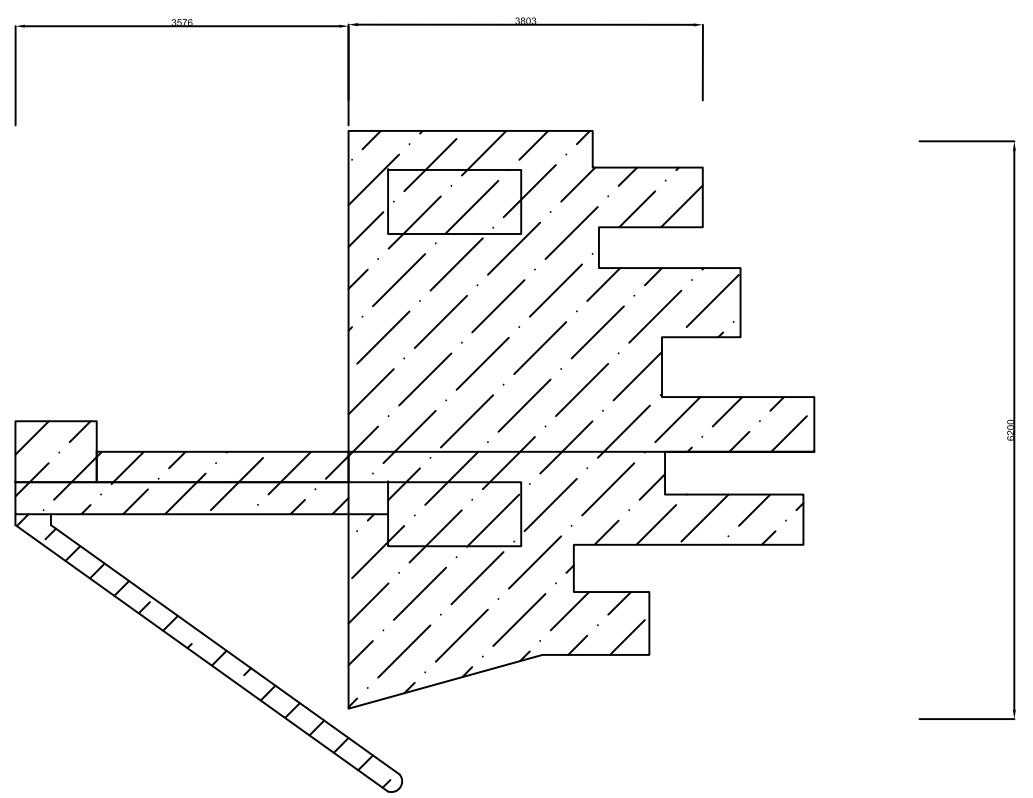
Three sections to be removed from the port hanger - ex HMAS Adelaide  
Estimated total weight in water 727kg
