McLennans Diving Service

- Marine Contractors

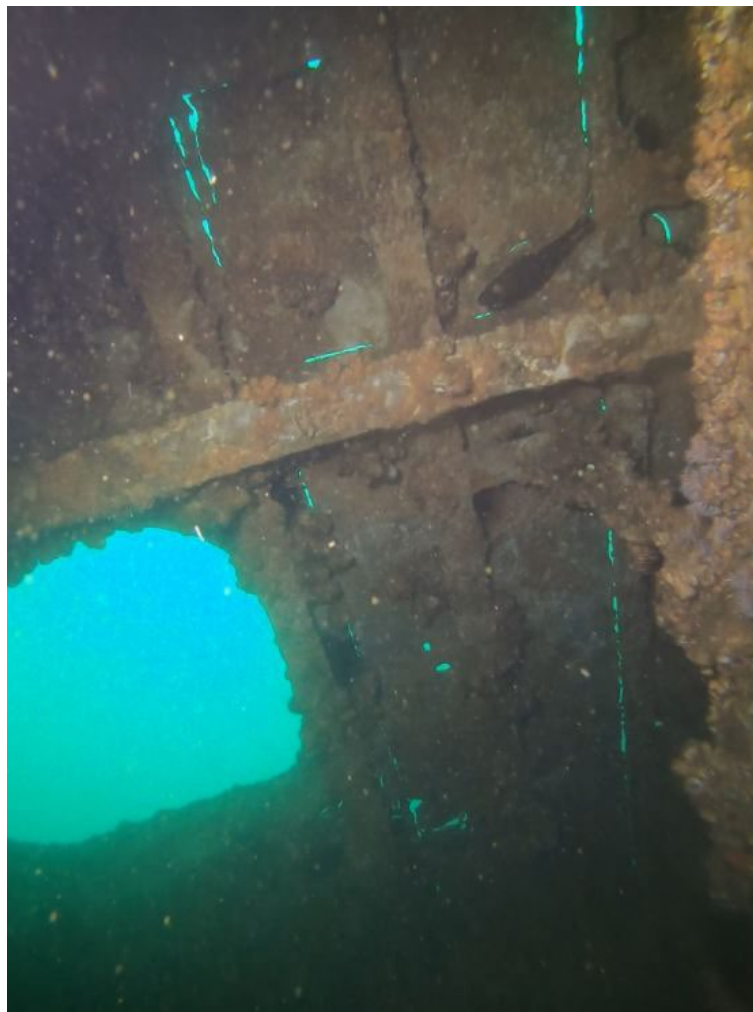
Figure 1: Looking up at the starboard hanger roof. Note the many corrosion holes.

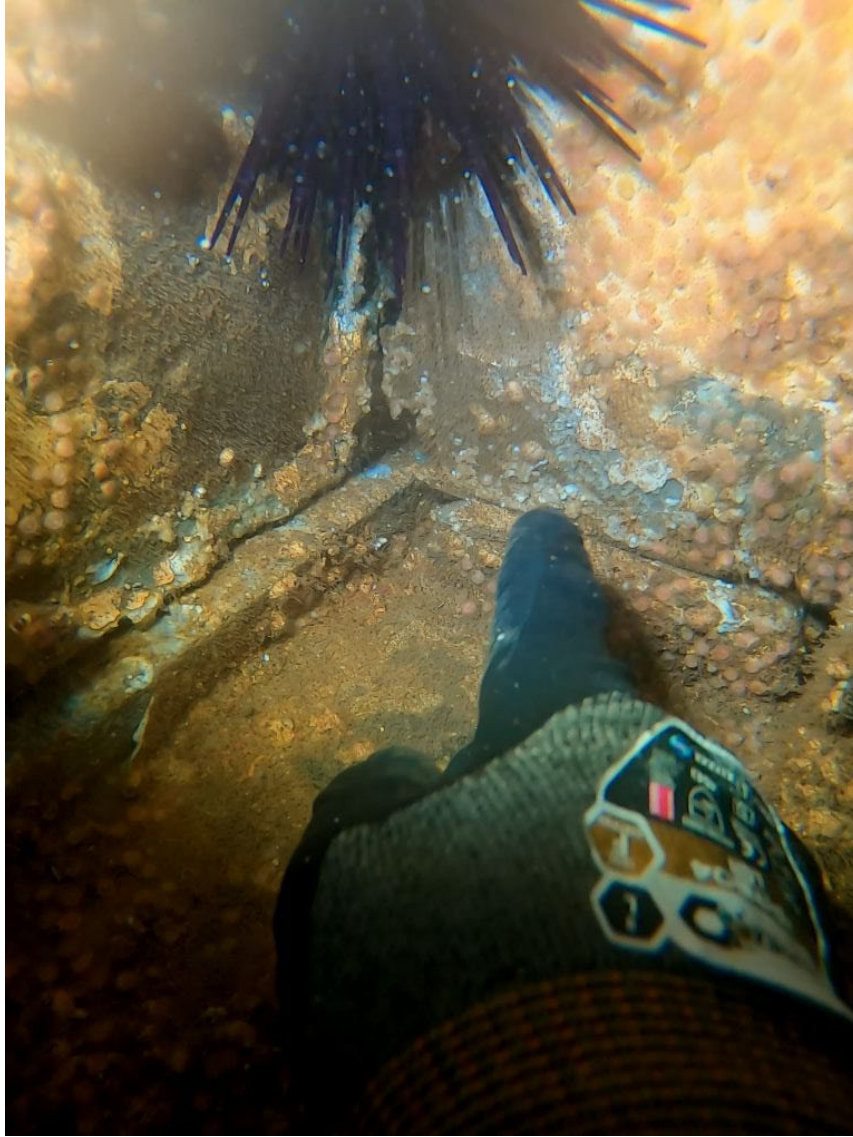
Figure 2: The divers hand pointing to the separation of the hanger companionway wall from the main deck. It is not currently presenting any dangers due to objects nearby holding it in position

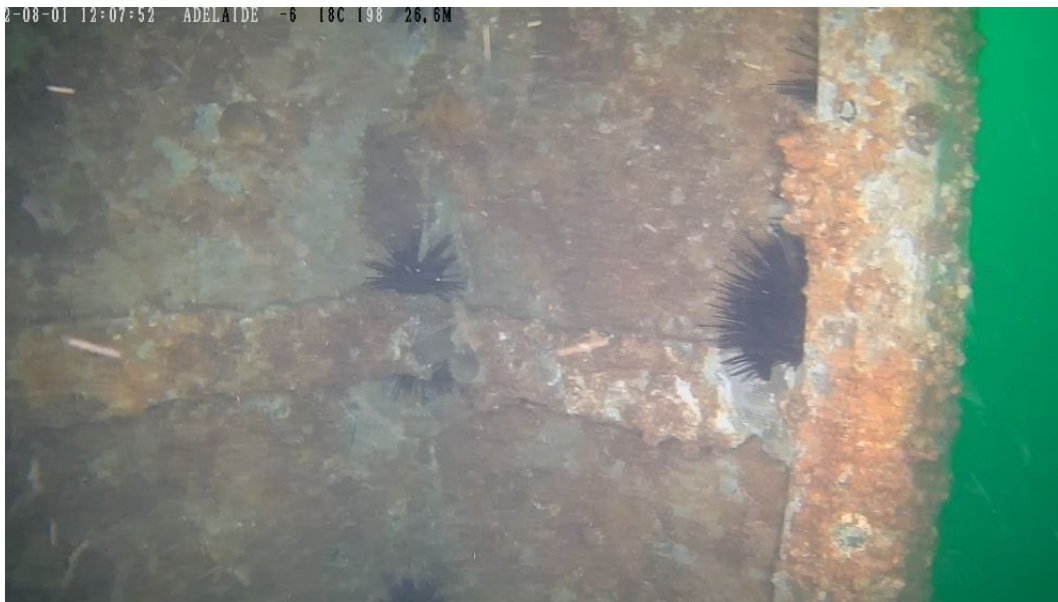
Figure 5: The aft supporting column of the starboard hanger looking from inboard. The column shows no sign of deterioration. The similar column on the port side showed cracking and crumpling in the weeks before the hanger collapsed.

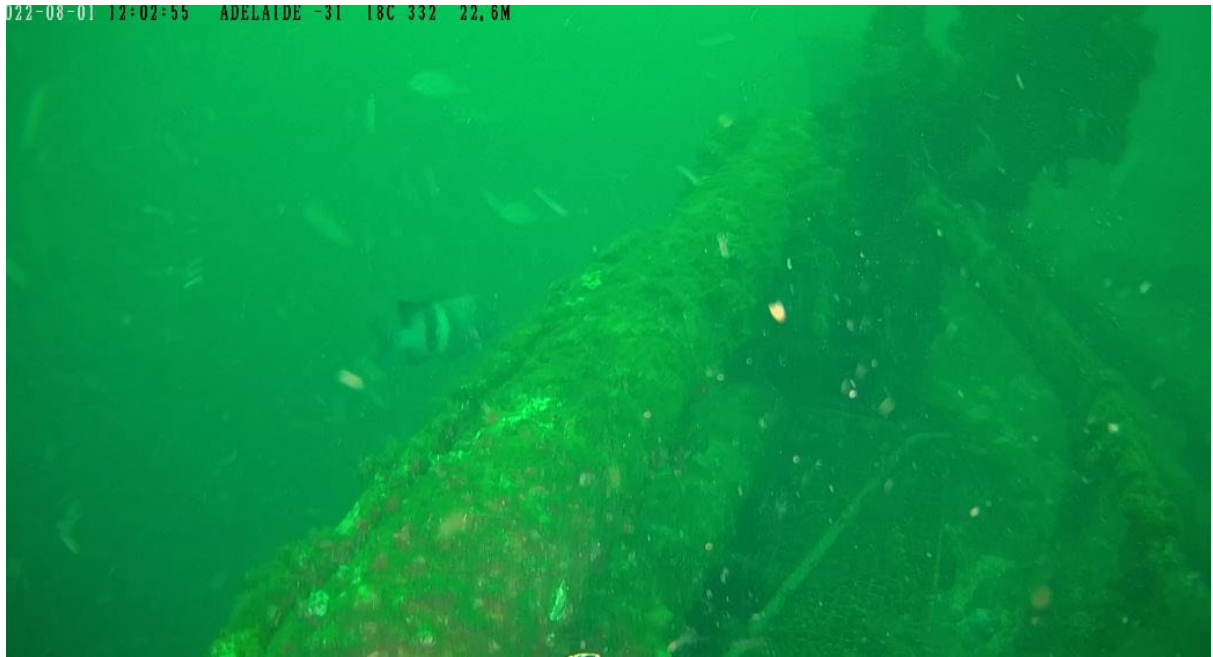
Figure 6: The starboard lifting davit on the hanger roof is folded in on the starboard side which places the load over the hanger door frame. This is in contrast with the port side on which the davit was cantilevered over the flight deck, which increased the load on the hanger.
