McLennans Diving Service

- Marine Contractors

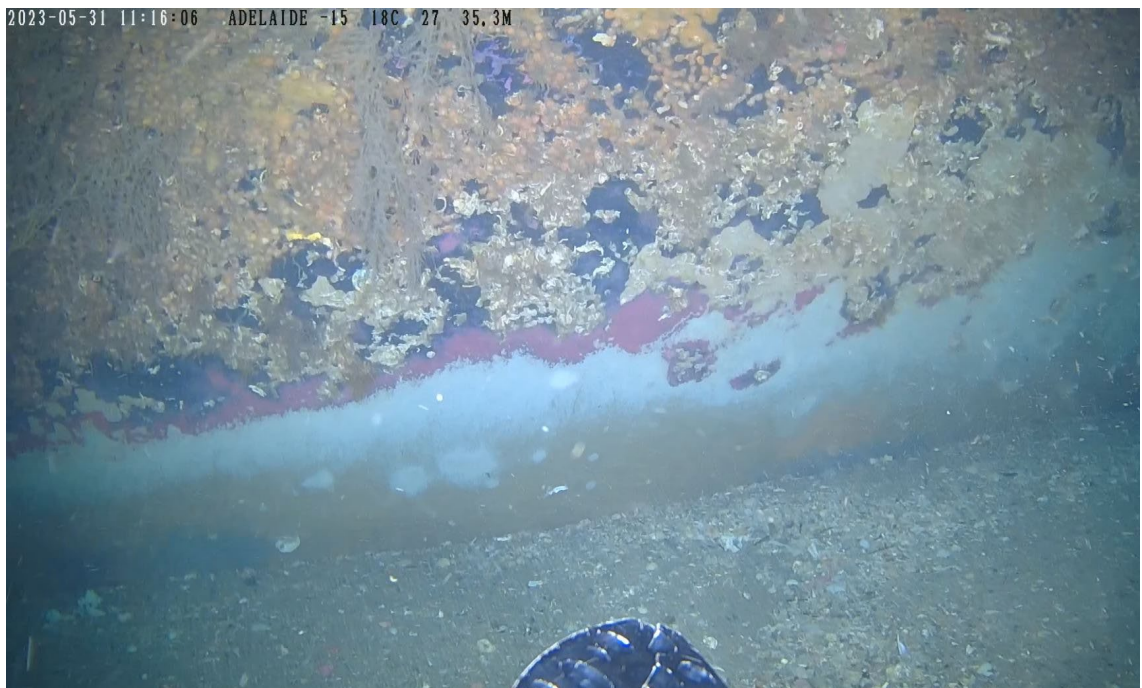
Figure 9: A typical view of the hull at the seabed. The paint coating are abraded off the hull, but no corrosion is occurring.

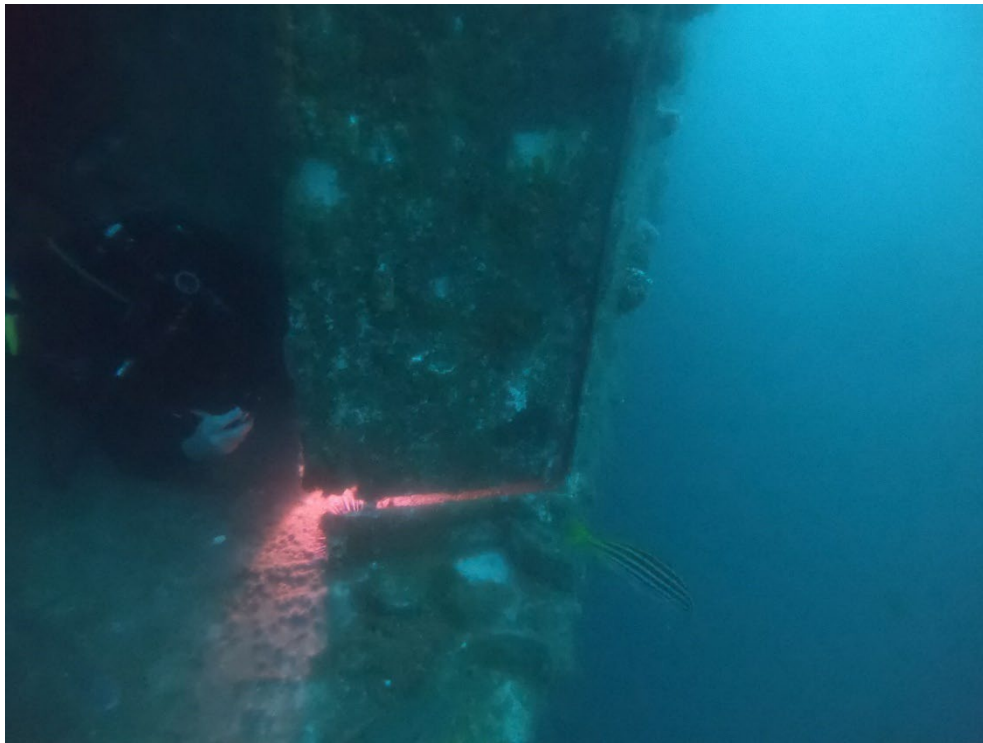
Figure 10: The swinging panel at the starboard walkway through the weather shield.

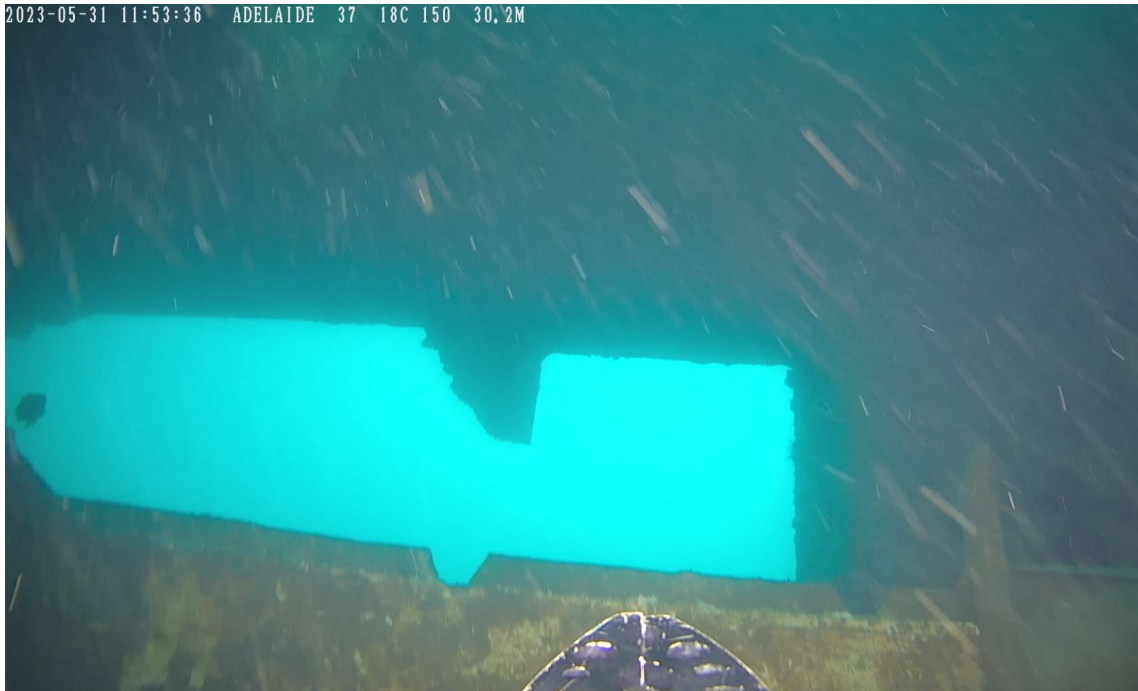
Figure 14: This is a view from No.2 deck through the wall of the lift shaft to the open starboard side.

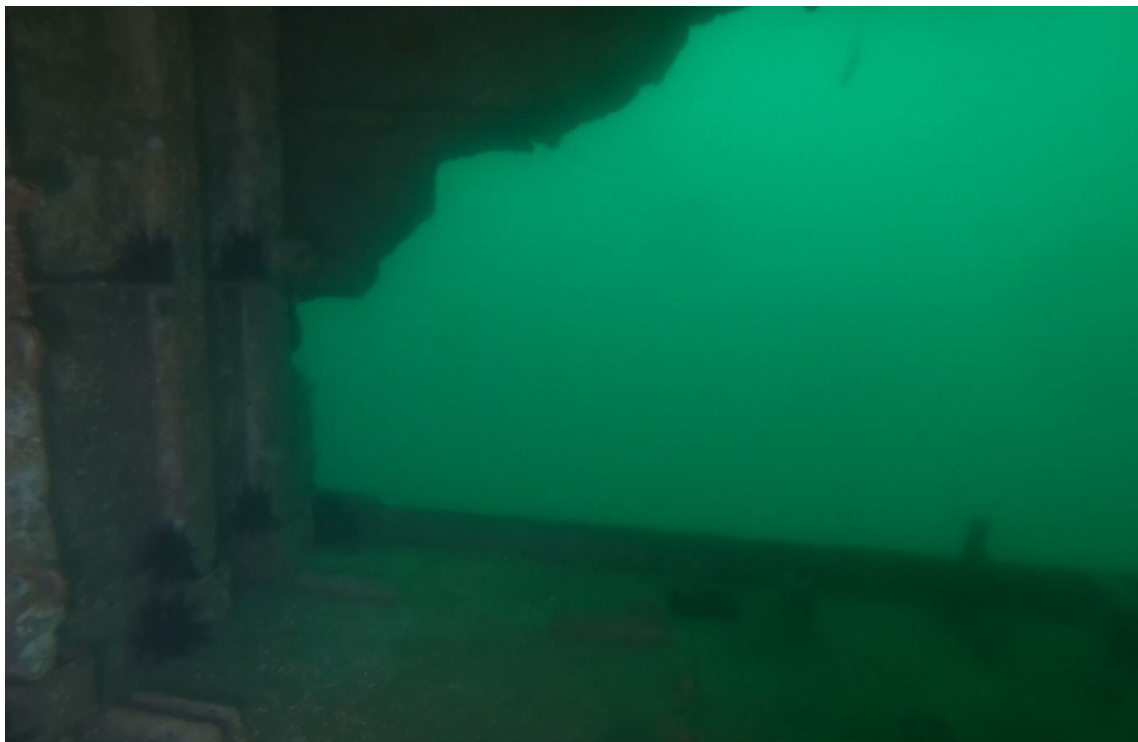
Figure 15: Typical missing outer wall on 01 deck. The aluminum panels have "blown out" in many places. However, it has aided light entry into the interior and has not created new dangers.

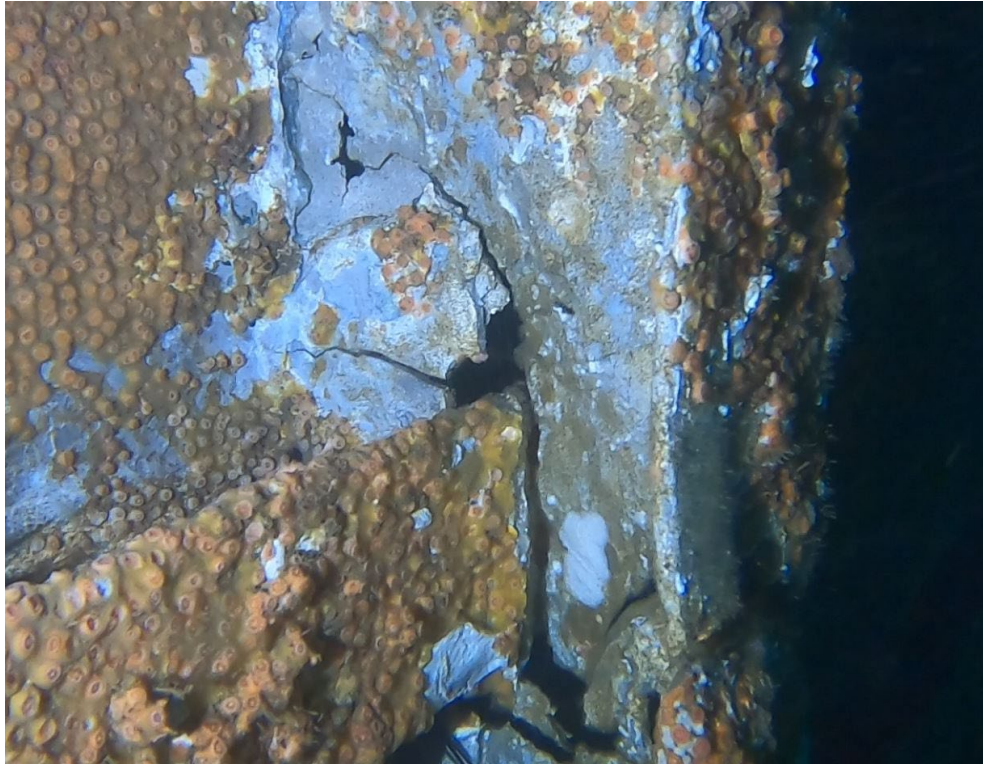
Figure 16: This is a typical aluminum frame and stringer on the exterior wall of 01 deck. The walls are breaking down due to cracking and corrosion and then the panels break off the superstructure.

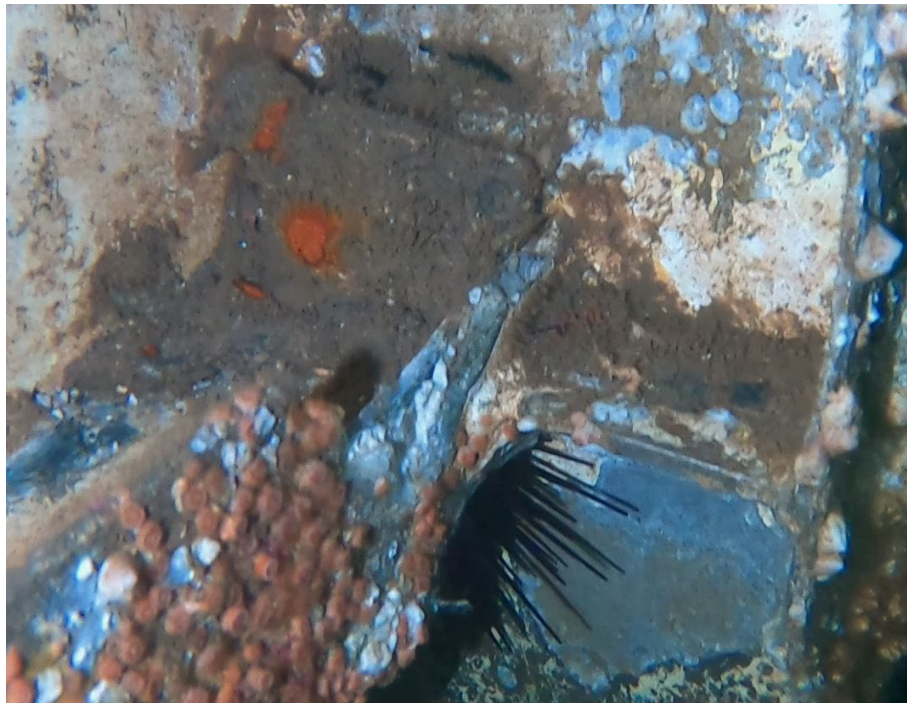
Figure 17: An example of the corrosion in the heat affected zones of the stringer connections to the frames.

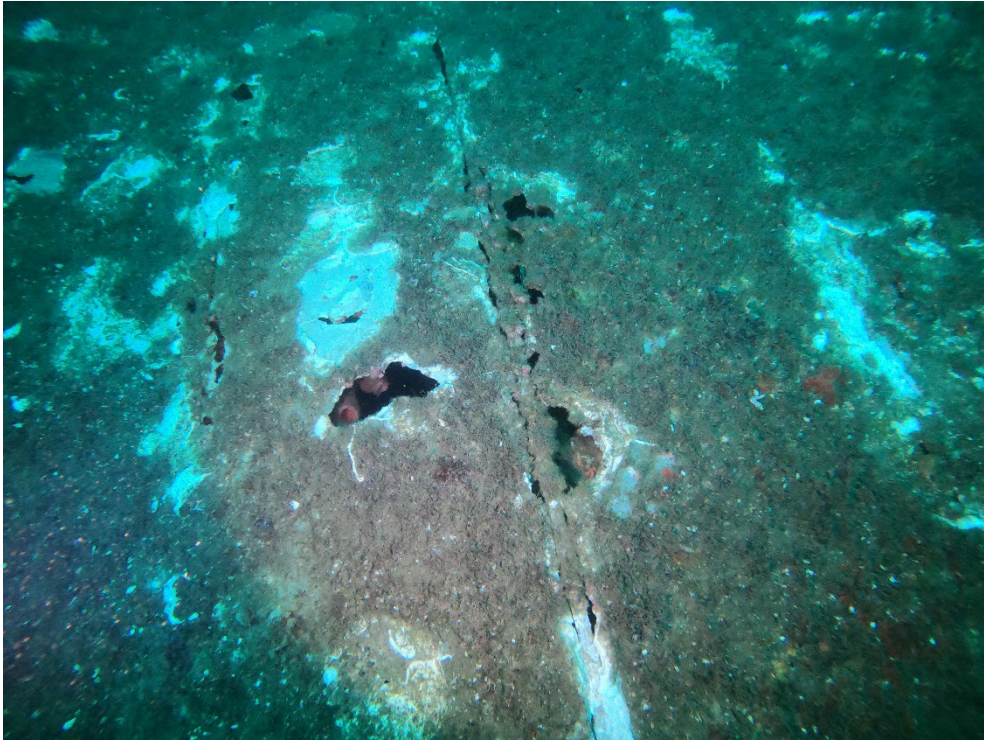
Figure 18: Corrosion of the Aluminum superstructure continues to increase dramatically each year.

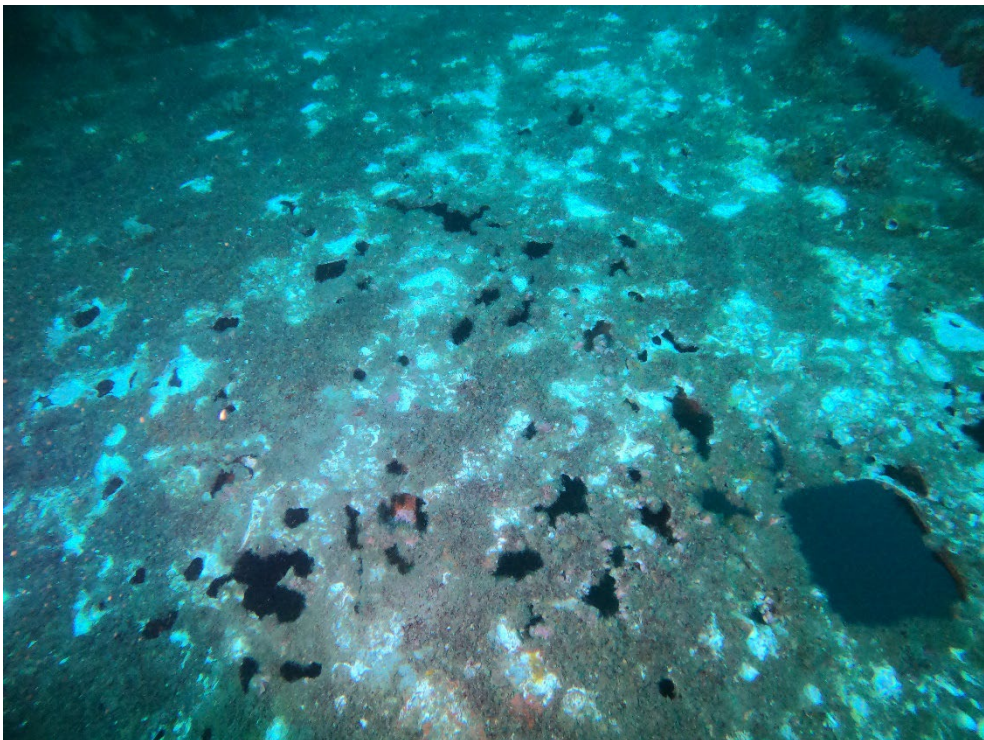
Figure 19: A view of the 02 deck with severe corrosion of the aluminum paneling

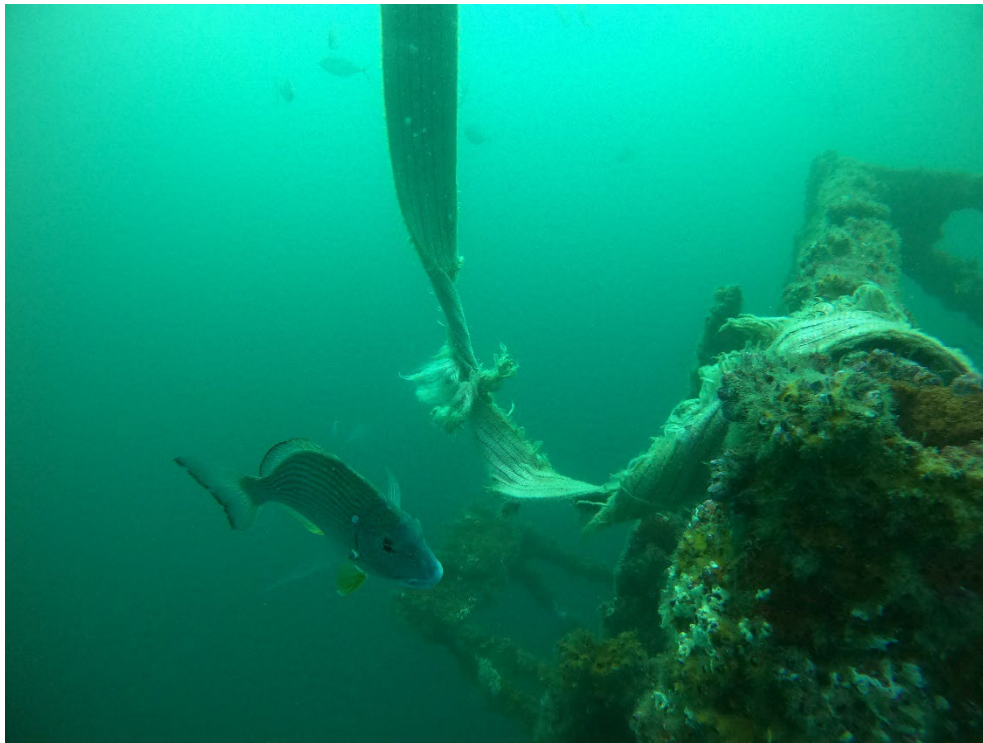
Figure 20: The main mast mooring is extremely chafed due to rubbing on the mast,

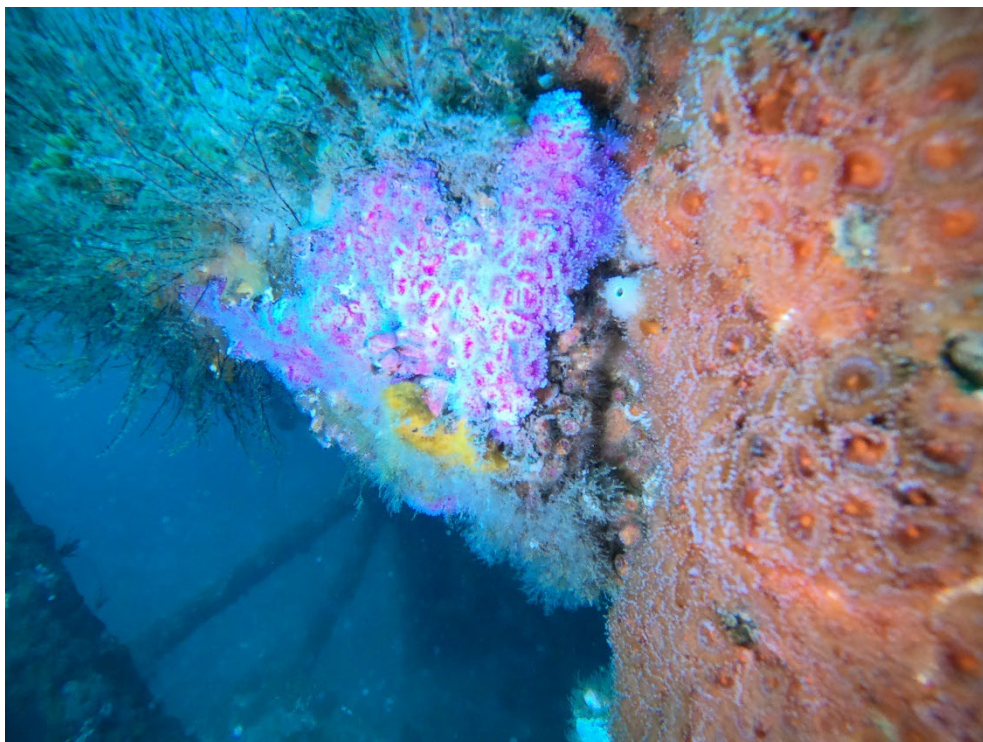
Figure 21: The mast is in sound condition and is heavily encrusted with colourful marine life.

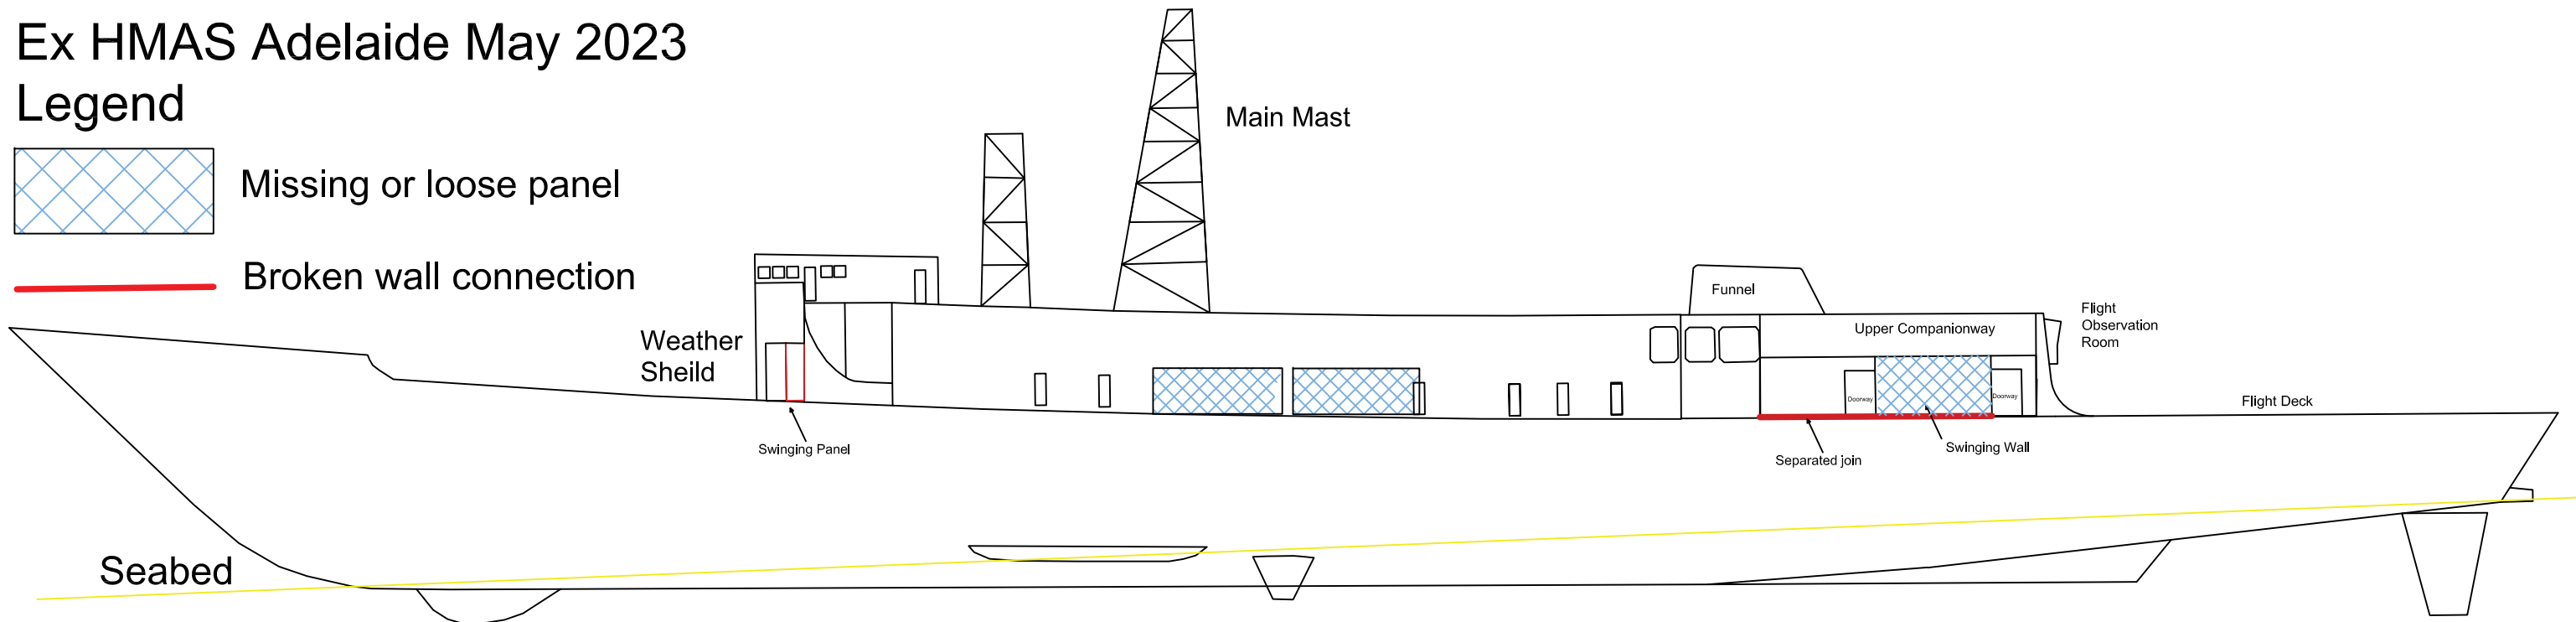
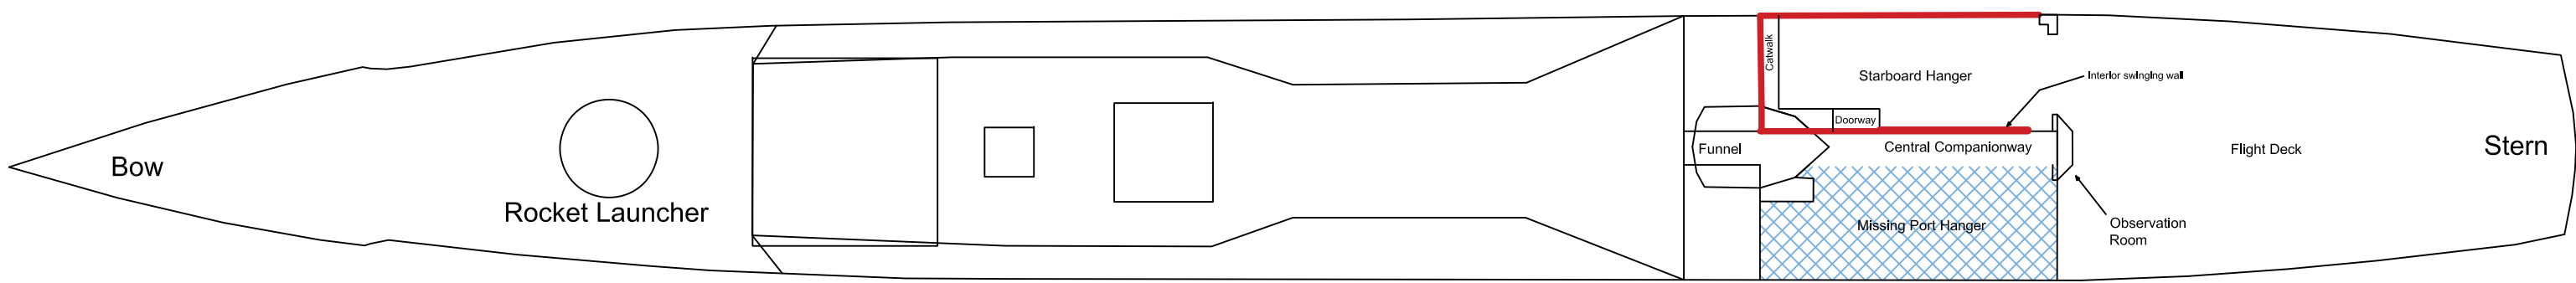
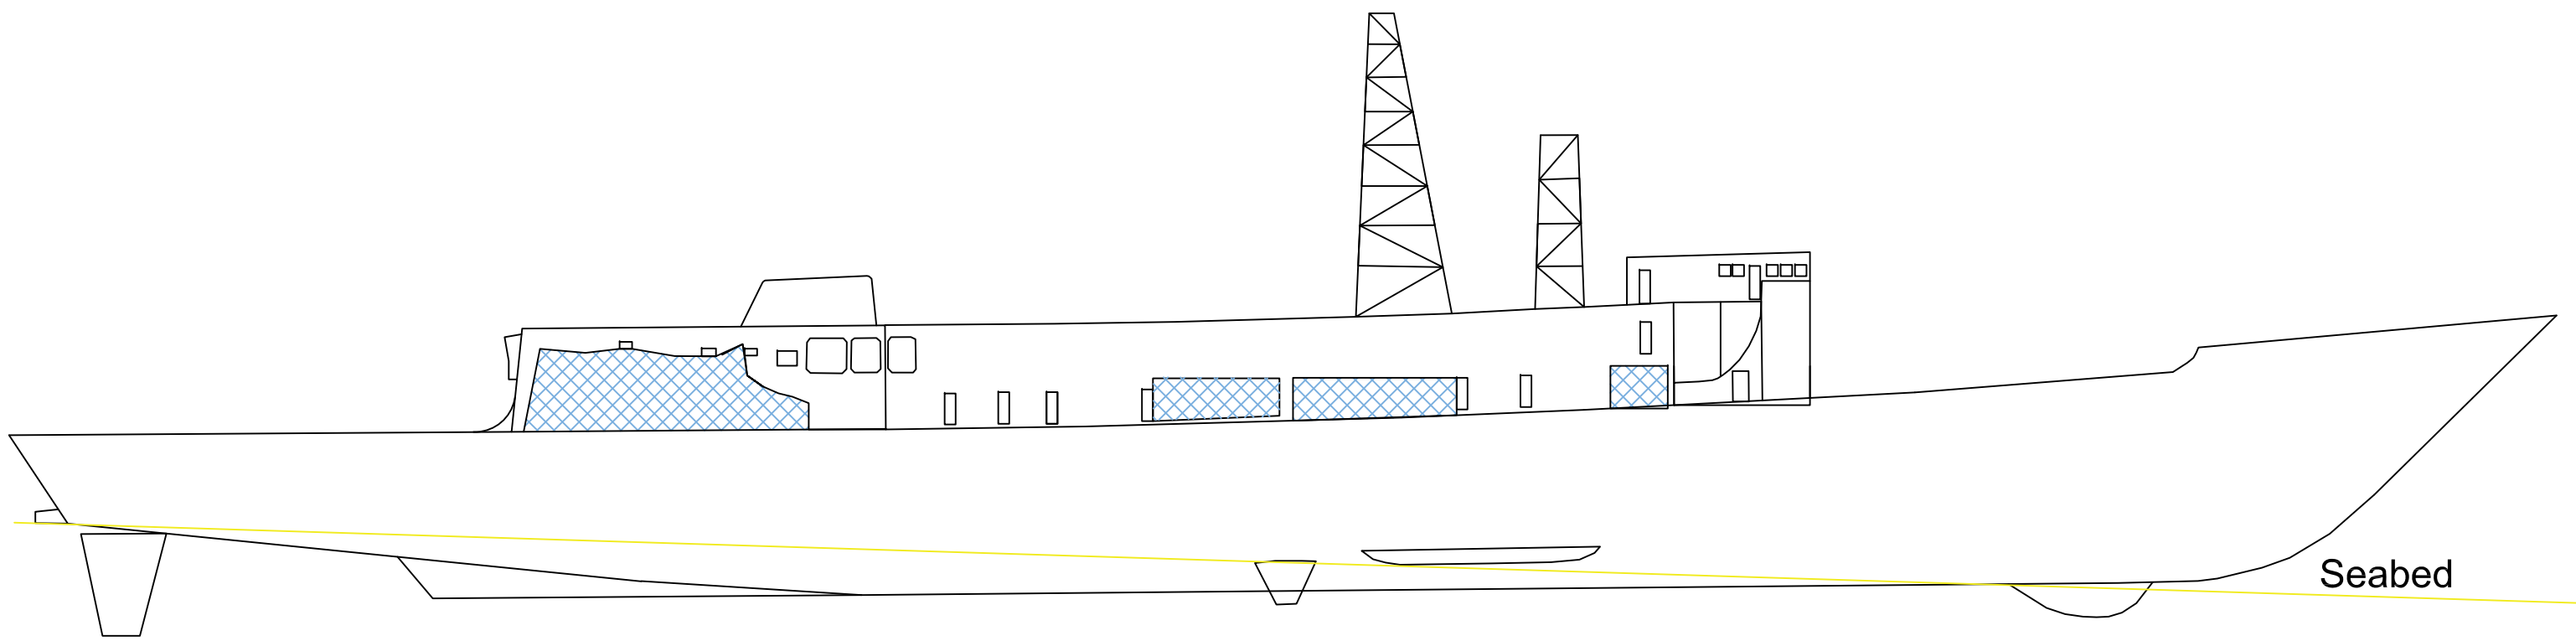
Broken wall connection
