Ex-HMAS Adelaide Artificial Reef

Review of Environmental Factors

301017-00077

2-Dec-09

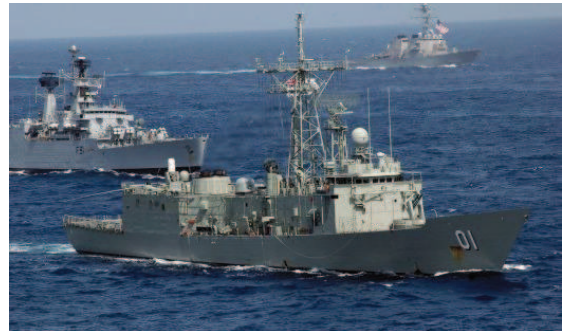
Heights were about 12m to the main deck, 18m to the bridge, 24m to the top of the foremast (the mast closest to the bow), and 39m to the top of the mainmast.

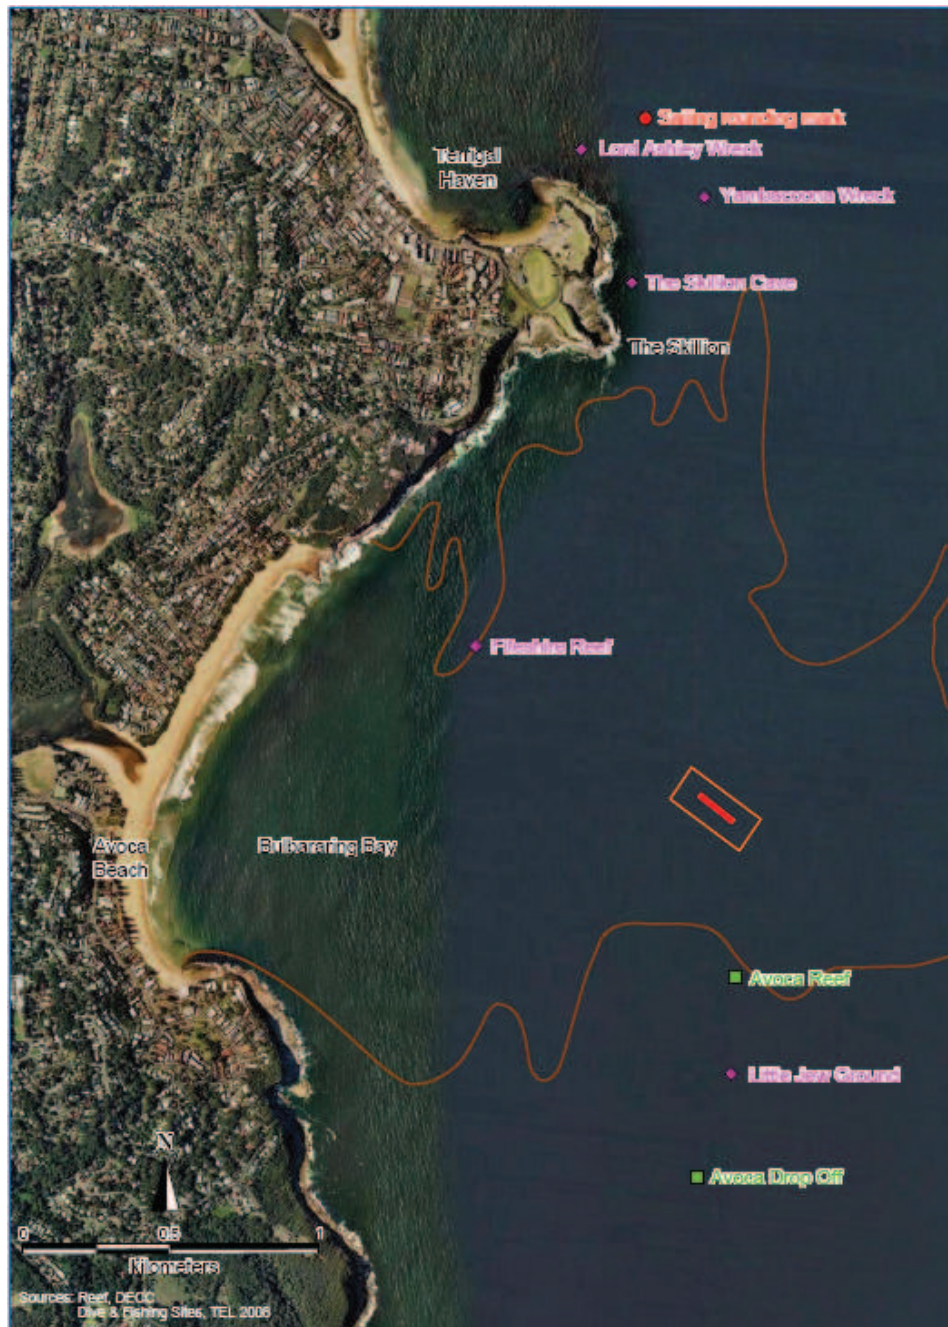
Figure 4.1 Scuttling Location

Skillion Rocks, with the distance between low tide at The Skillion and the stern, centre and bow of the ship being approximately 1.41, 1.47 and 1.54km respectively. The distance to the reef to the south of the ship would be around 400m. Directly east, to low tide in Bulbararing Bay the distance between the stern, centre and bow of the ship would be approximately 1.84, 1.90 and 1.97km respectively (see **Figure 4.1** which shows the scuttling location with the ship indicated in red and surrounding rectangular exclusion zone).

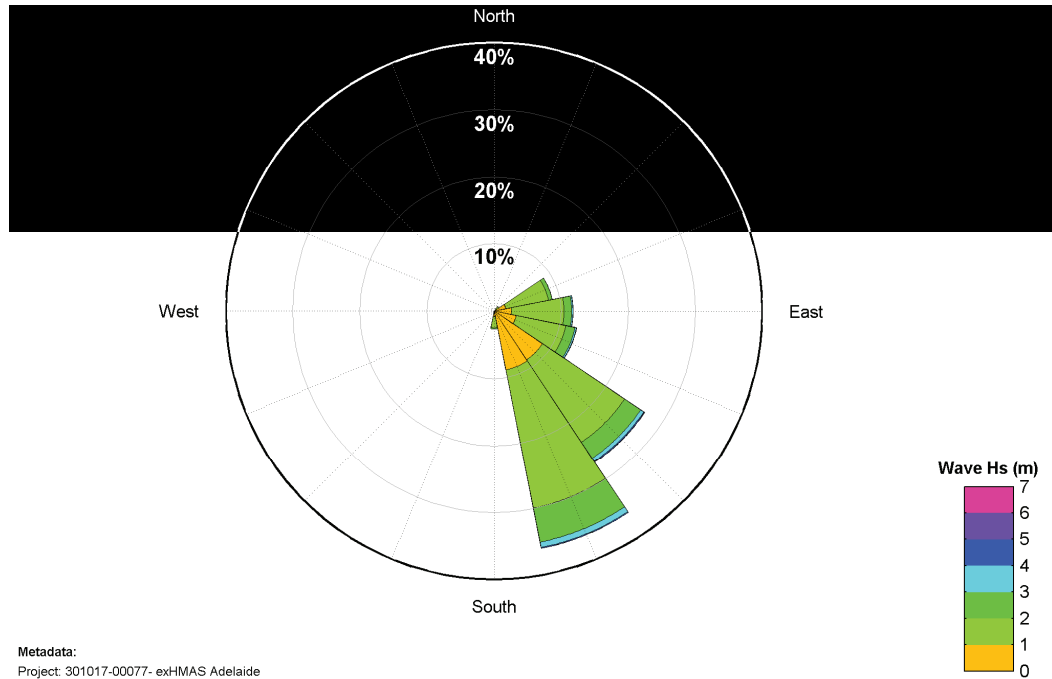
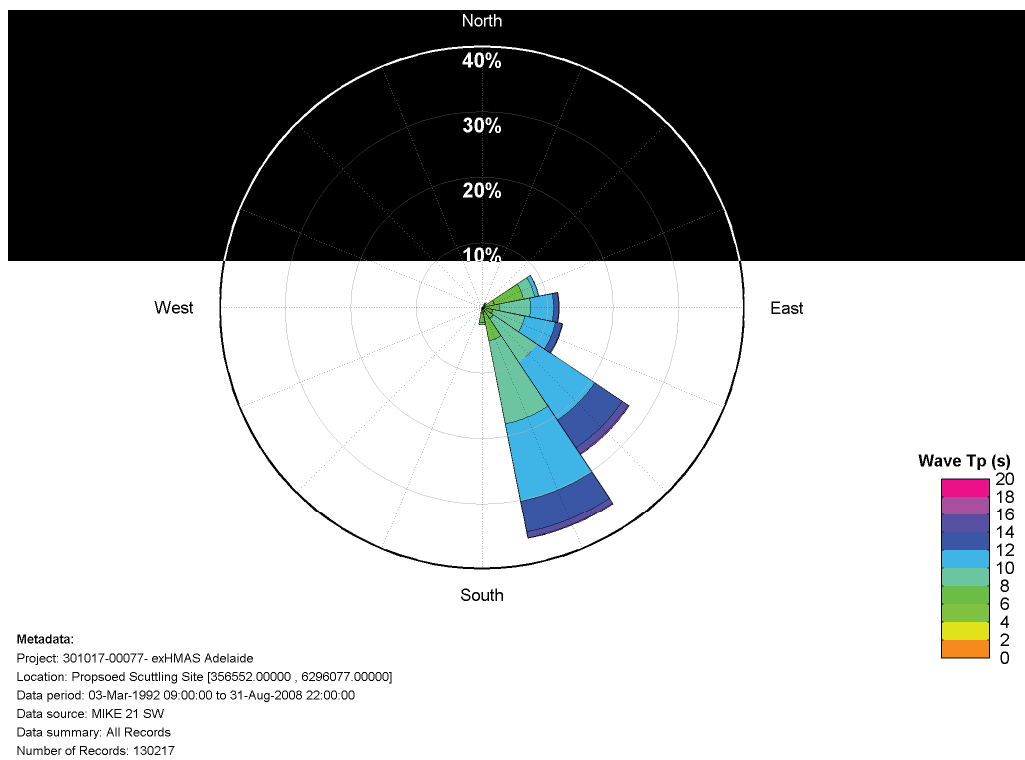
Figure 5.4 Scuttling Site Wave Height and Wave Period

The expected 100 year ARI design wave height (H_s) at the scuttling site was calculated as 8.4m and occurring from the SE. This is compared to the equivalent offshore design wave height of 9.3m from the SSE.

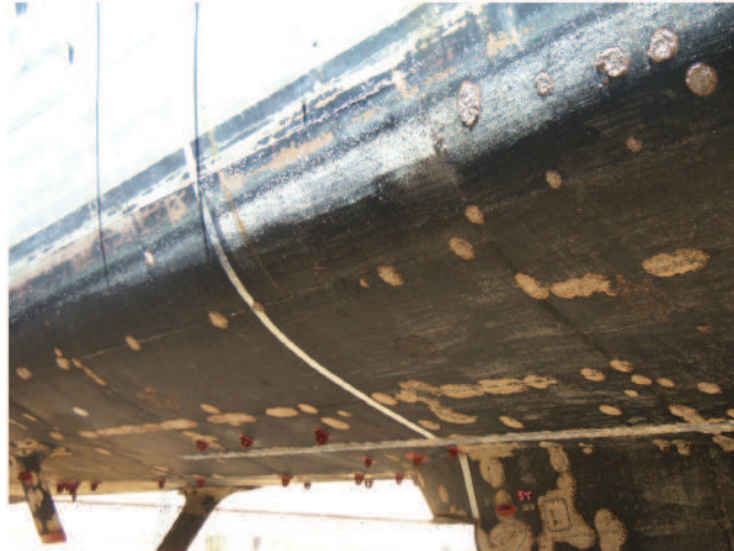
Photo 6.1 Ex-HMAS ADELAIDE in Dry Dock

The Ex-HMAS ADELAIDE was dry docked on 29 August 2008 and re-entered the water again at Garden Island on 29 September 2008. Prior to re-entry an inspection of the vessel hull was undertaken to document hull fouling organisms and the presence of any marine pests. No introduced marine pest species were found and all organisms observed, primarily barnacle and bryozoan fauna, were found to be dead and desiccated due to the one-month period in dry dock, see **Photograph 6.1**.

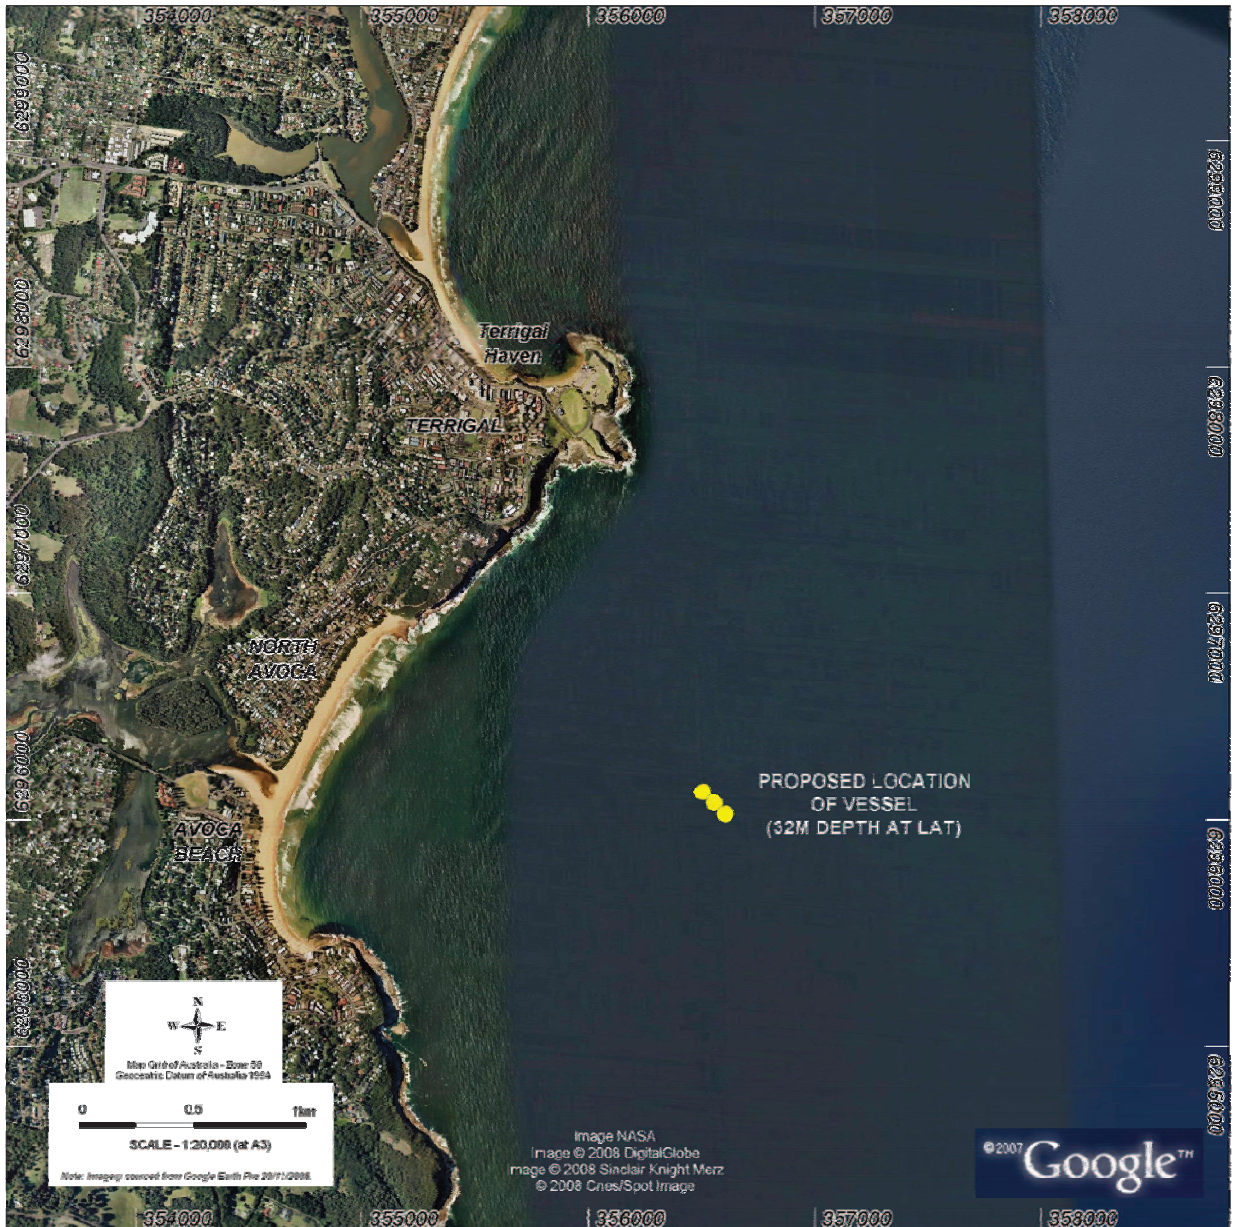
Figure 1-1 Proposed location of the Ex-HMAS ADELAIDE dive reef.

adjacent to Avoca Beach near Terrigal (TEL, 2008); and sidescan sonar and seismic reflection profiling surveys (Douglas Partners, 2008) that enabled mapping of seabed characteristics and underlying bedrock to ascertain the depths of overlying sand available for vessel penetration. A preferred scuttling site was subsequently identified in Bulbararing Bay, 1.87 km offshore from Avoca Beach in approximately 32 m of water (at lowest astronomical tide (LAT)). This site has a reasonably flat sandy substrate with up to 6 m of sand overlying bedrock (**Figure 1-1**).

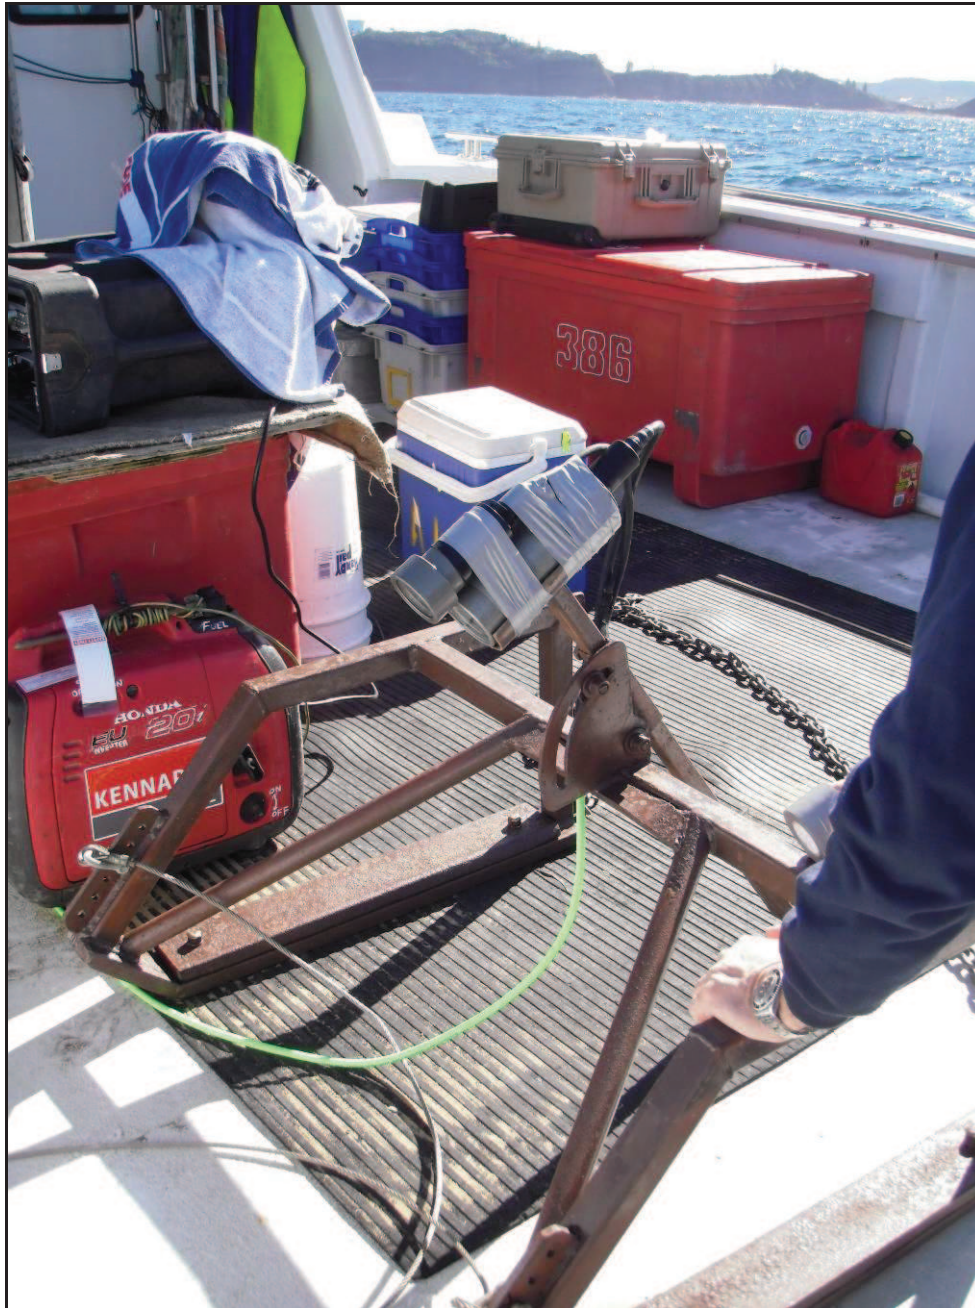
Figure 2-1 Light-equipped remotely operated underwater video camera mounted to a sled.

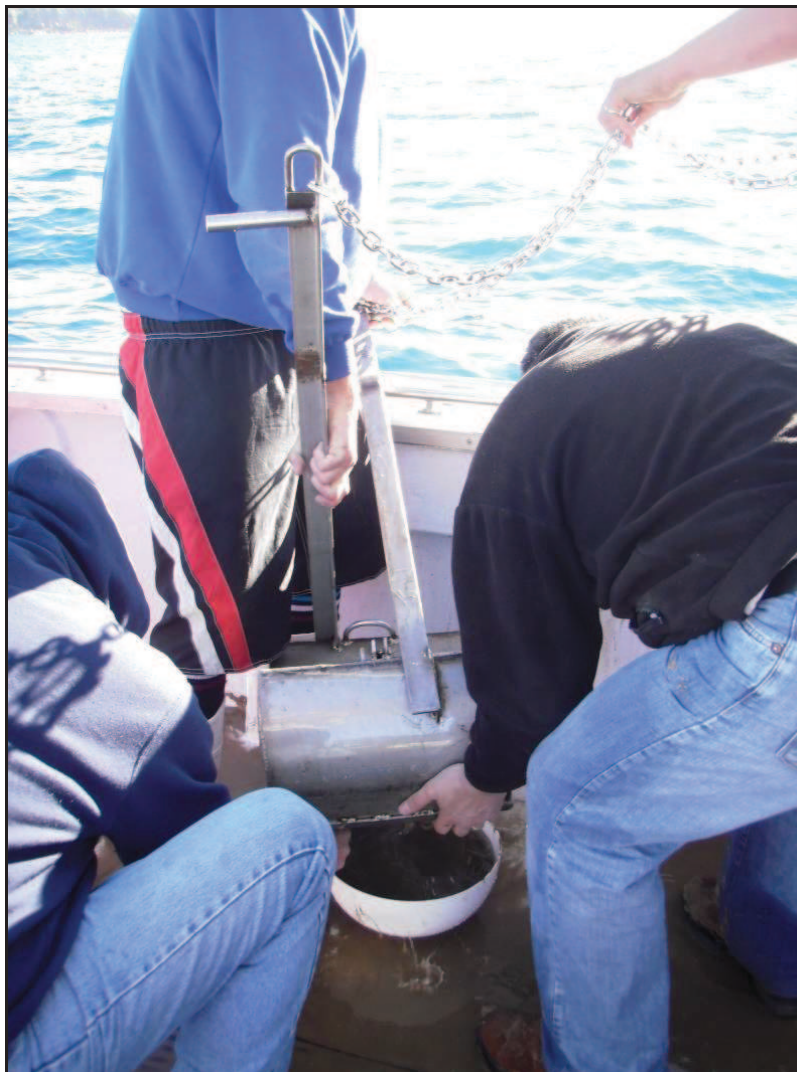
Figure 2-3 van Veen grab sampler.

Single sediment grab samples were collected at three locations along the proposed centre line of the vessel (i.e. stern, middle and bow; sites V1 – V3) and from the seven random grid-selected locations near the proposed wreck site (sites S1 – S7) (see **Figure 2-2**). Sediments were collected from the surface to a depth of approximately 100 - 150 mm, using a stainless steel van Veen grab sampler (**Figure 2-3**). The grab sampler was slowly lowered from the survey vessel to the seabed and retrieved following sediment capture. The collected sediment was emptied into a clean plastic core tray and packaged separately in glass jars for contaminant (metals/metalloids) testing, and in plastic bags for particle size analyses. All samples were kept in the dark and on ice until delivery to the analytical laboratory the following day.

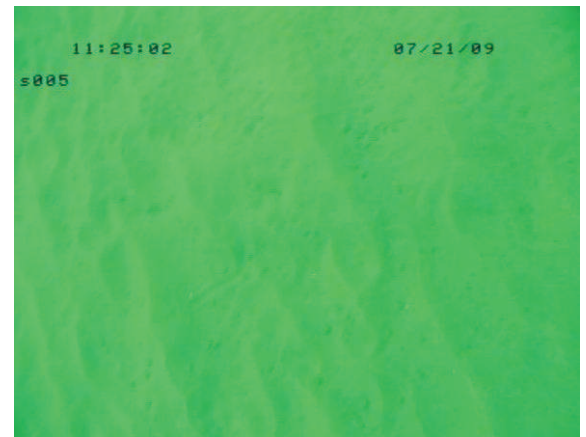
Figure 3-2 Sandy seabed habitat (Sites S4 and S5).

Seven soft seabed sites (S1-S7) were inspected using the drop-camera. Of the seven sites, six sites were confirmed as sand while Site S7 was rocky reef. Sites S1 through to S6 were largely compact, contoured sand with very little epifauna or macroalgae present (**Figure 3-2**). Some evidence of bioturbation was noted at some of the sites. Fish were generally uncommon over the sandy seabed sites with the exception of rays which were encountered at most of the sites.
