Ex HMAS Adelaide Artificial Reef Sediment Quality Monitoring Survey 3

Job Number: 59916176

**Prepared for NSW Department of Primary Industries - Lands
September 2016**

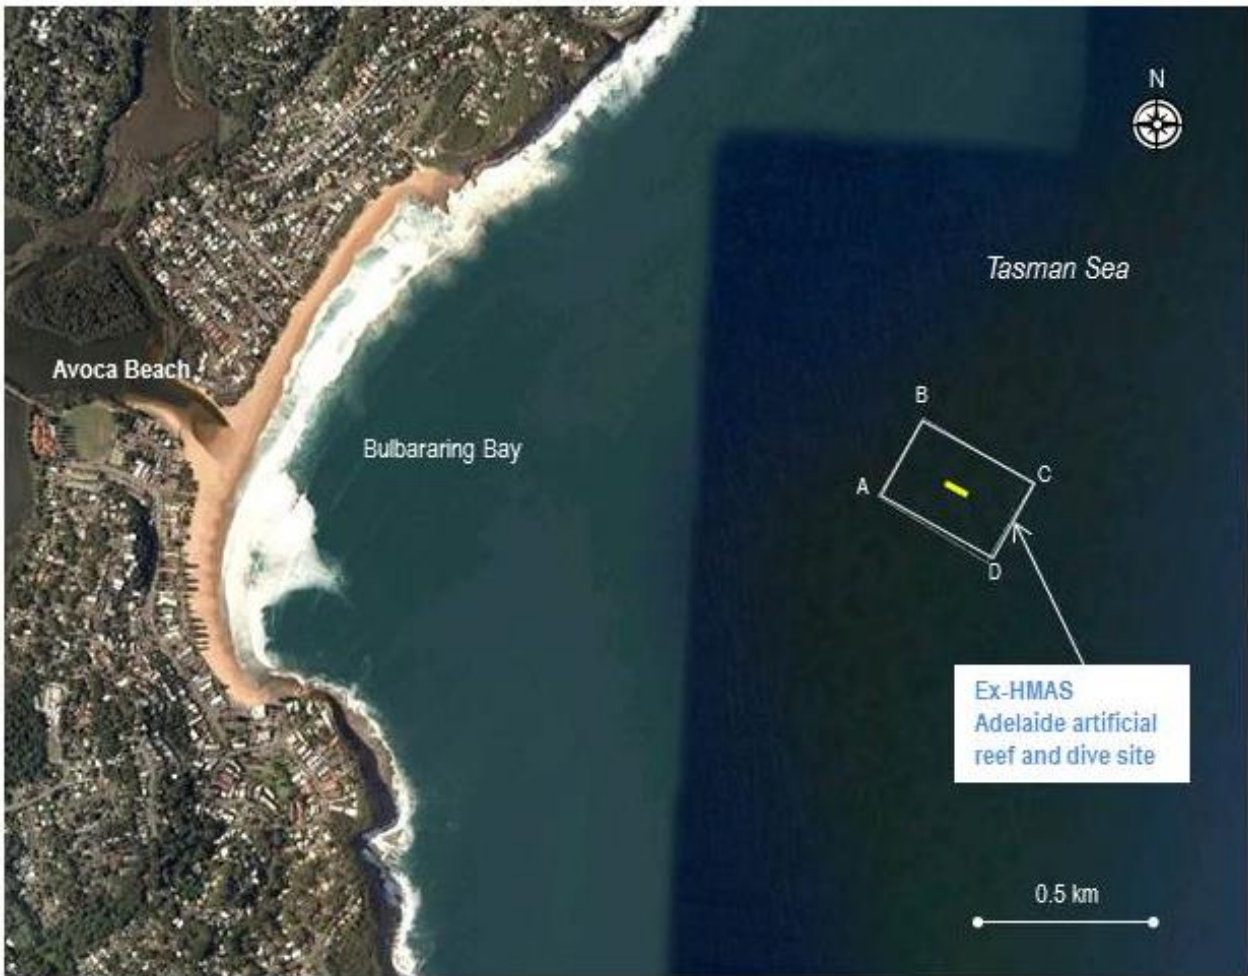
Boundary of Dive Site	Easting (MGA 94)	Northing (MGA 94)
A	356428.713	6296117.693
B	356538.438	6296341.142
C	356850.615	6296188.618
D	356742.410	6295963.310

Figure 1: Location of Ex-HMAS Adelaide Artificial Reef and Dive Site. The approximate location and orientation of the ship is indicated by the yellow line.

The Ex-HMAS Adelaide artificial reef and dive site is located within Bulbararing Bay, approximately 1.87 km offshore from Avoca Beach. The ship lies at a depth of approximately 32 m to 34 m of water at Lowest Astronomical Tide (LAT) on top of a relatively flat, sandy substratum. There is a minimum of 6 m of sand overlying bedrock. The vessel is orientated with the bow facing into the prevailing ESE swell direction (**Figure 1**).

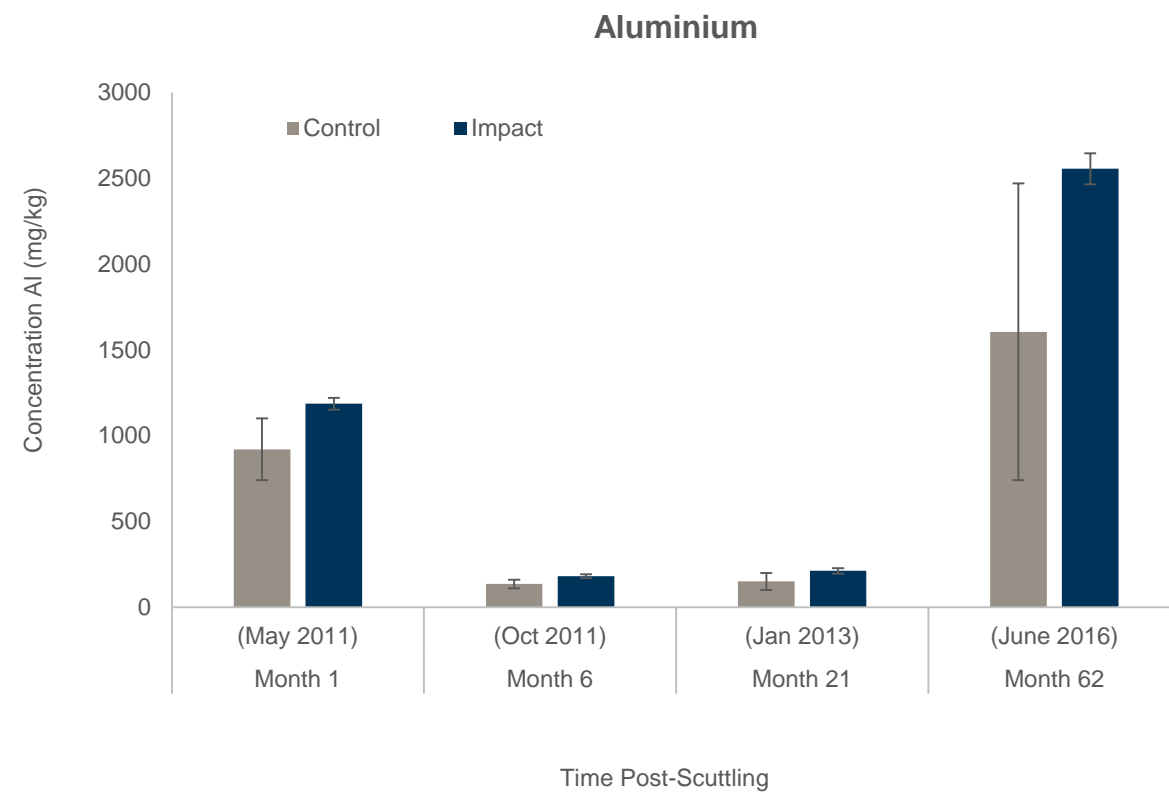
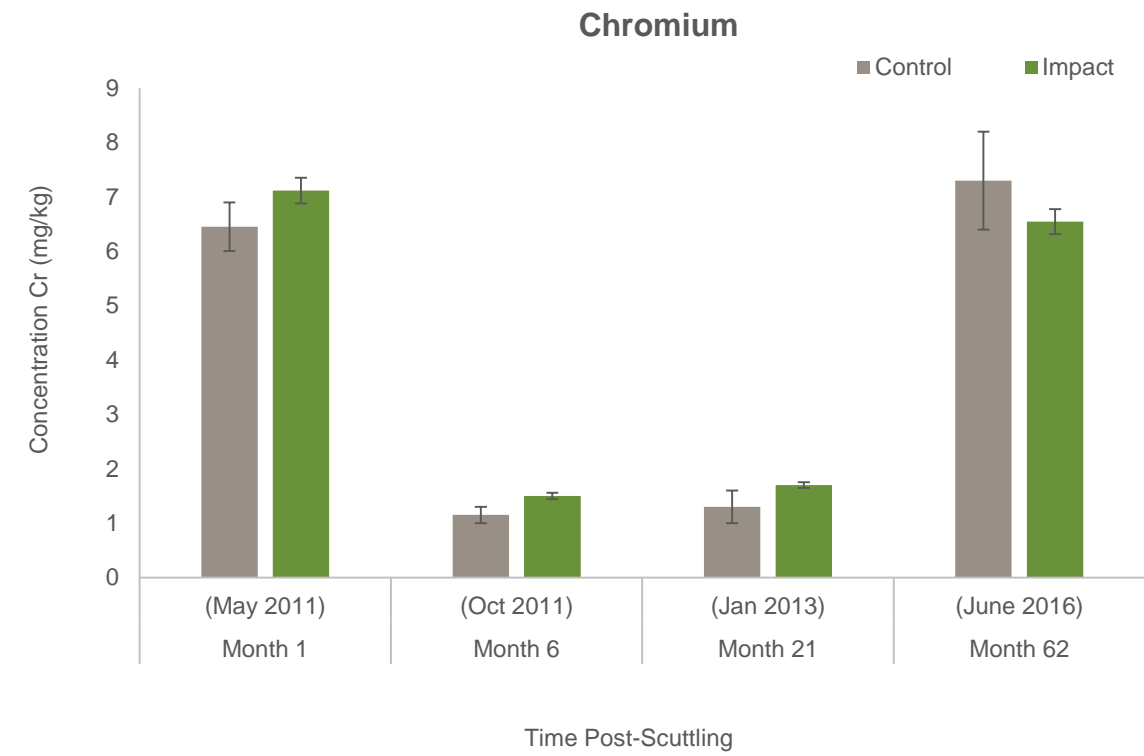
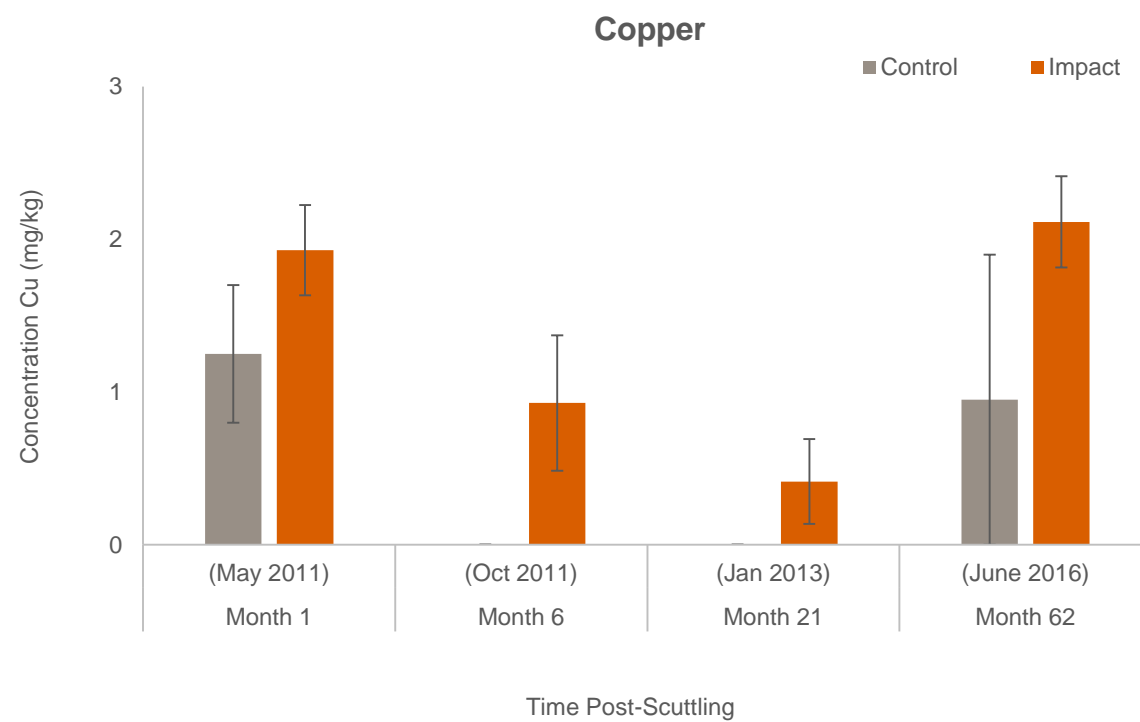
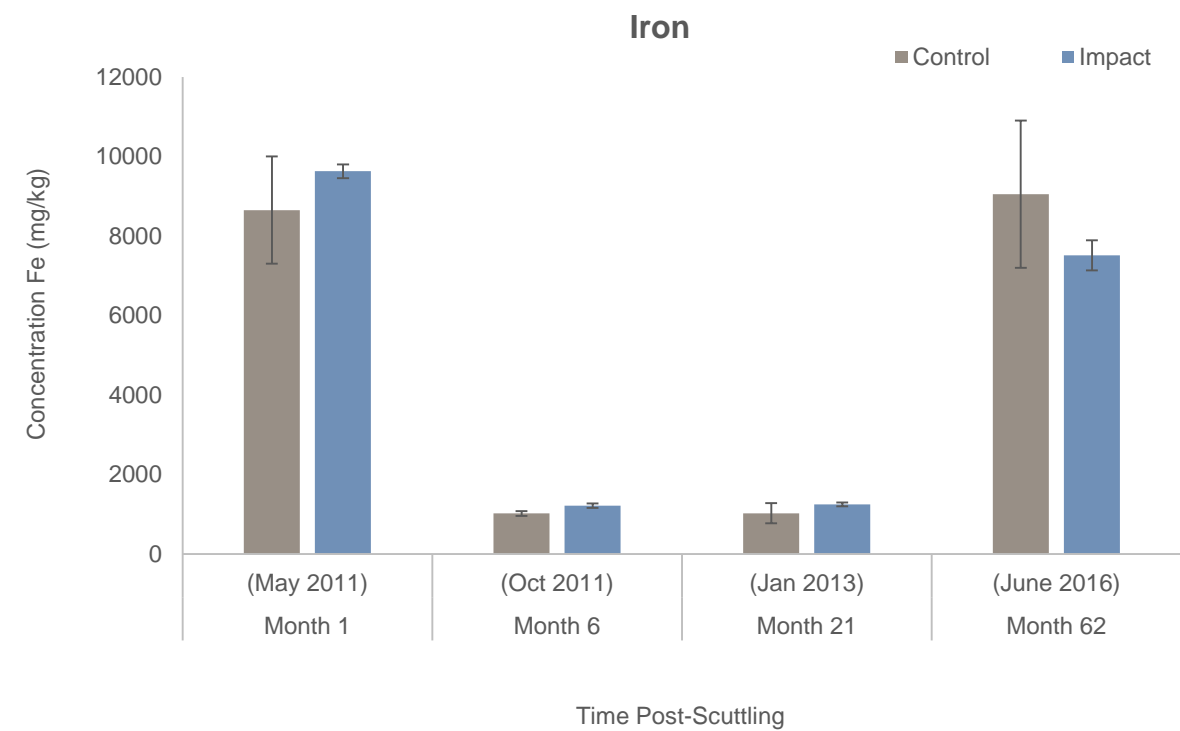
Figure 3. Mean Heavy Metal Concentrations Recorded in Sediment Samples Collected from Monitoring and Control Locations during May 2011 (one month post-scuttling), October 2011 (six months post-scuttling), January 2013 (21 months post-scuttling) and June 2016 (62 months post scuttling)

Concentrations of metal contaminants in sediment samples are provided in **Table 2** and **Figure 3**. Raw lab data is provided in **Appendix 1**. The main findings are summarised as follows:

Mean concentrations of Al detected 62 months post-scuttling (June 2016) was greater than the levels detected during all other surveys in samples collected from both control and impact sites. The mean Al concentration in samples collected during the June 2016 survey was also greater in the impact sites in comparison with the control sites, although a large difference in Al concentrations between control sites S3 and S6, contributed to a large S.E. within the control treatment and this difference was not therefore statistically significantly different. No ANZECC/ARMCANZ (2000) guidelines apply to Al in marine sediments.

Mean concentrations of Cr detected 62 months post-scuttling (June 2016), was similar to that recorded one month post-scuttling (May 2011) in both control and impact locations despite an overall decrease during surveys carried out 6 (Oct 2011) and 21 months (Jan 2013) post-scuttling. Concentrations of Cr were well below the ANZECC/ARMCANZ (2000) ISQG lower trigger value of 80 mg/kg in all surveys.

Mean concentrations of Cu detected 62 months post-scuttling (June 2016) was similar to that recorded one month post-scuttling (May 2011) despite an overall decrease during surveys carried out 6 (Oct 2011) and 21 months (Jan 2013) post-scuttling. Concentrations of Cu were well below the ANZECC/ARMCANZ (2000) ISQG lower trigger value of 60 mg/kg in all surveys.

Mean concentrations of Fe detected 62 months post-scuttling (June 2016), was similar to that recorded one month post-scuttling (May 2011) in both control and impact locations despite an overall decrease during surveys carried out 6 (Oct 2011) and 21 months (Jan 2013) post-scuttling. No ANZECC/ARMCANZ (2000) guidelines apply to Al in marine sediments.
