Enmore Park

plan of management + masterplan

ENMORE PARK PLAN OF MANAGEMENT

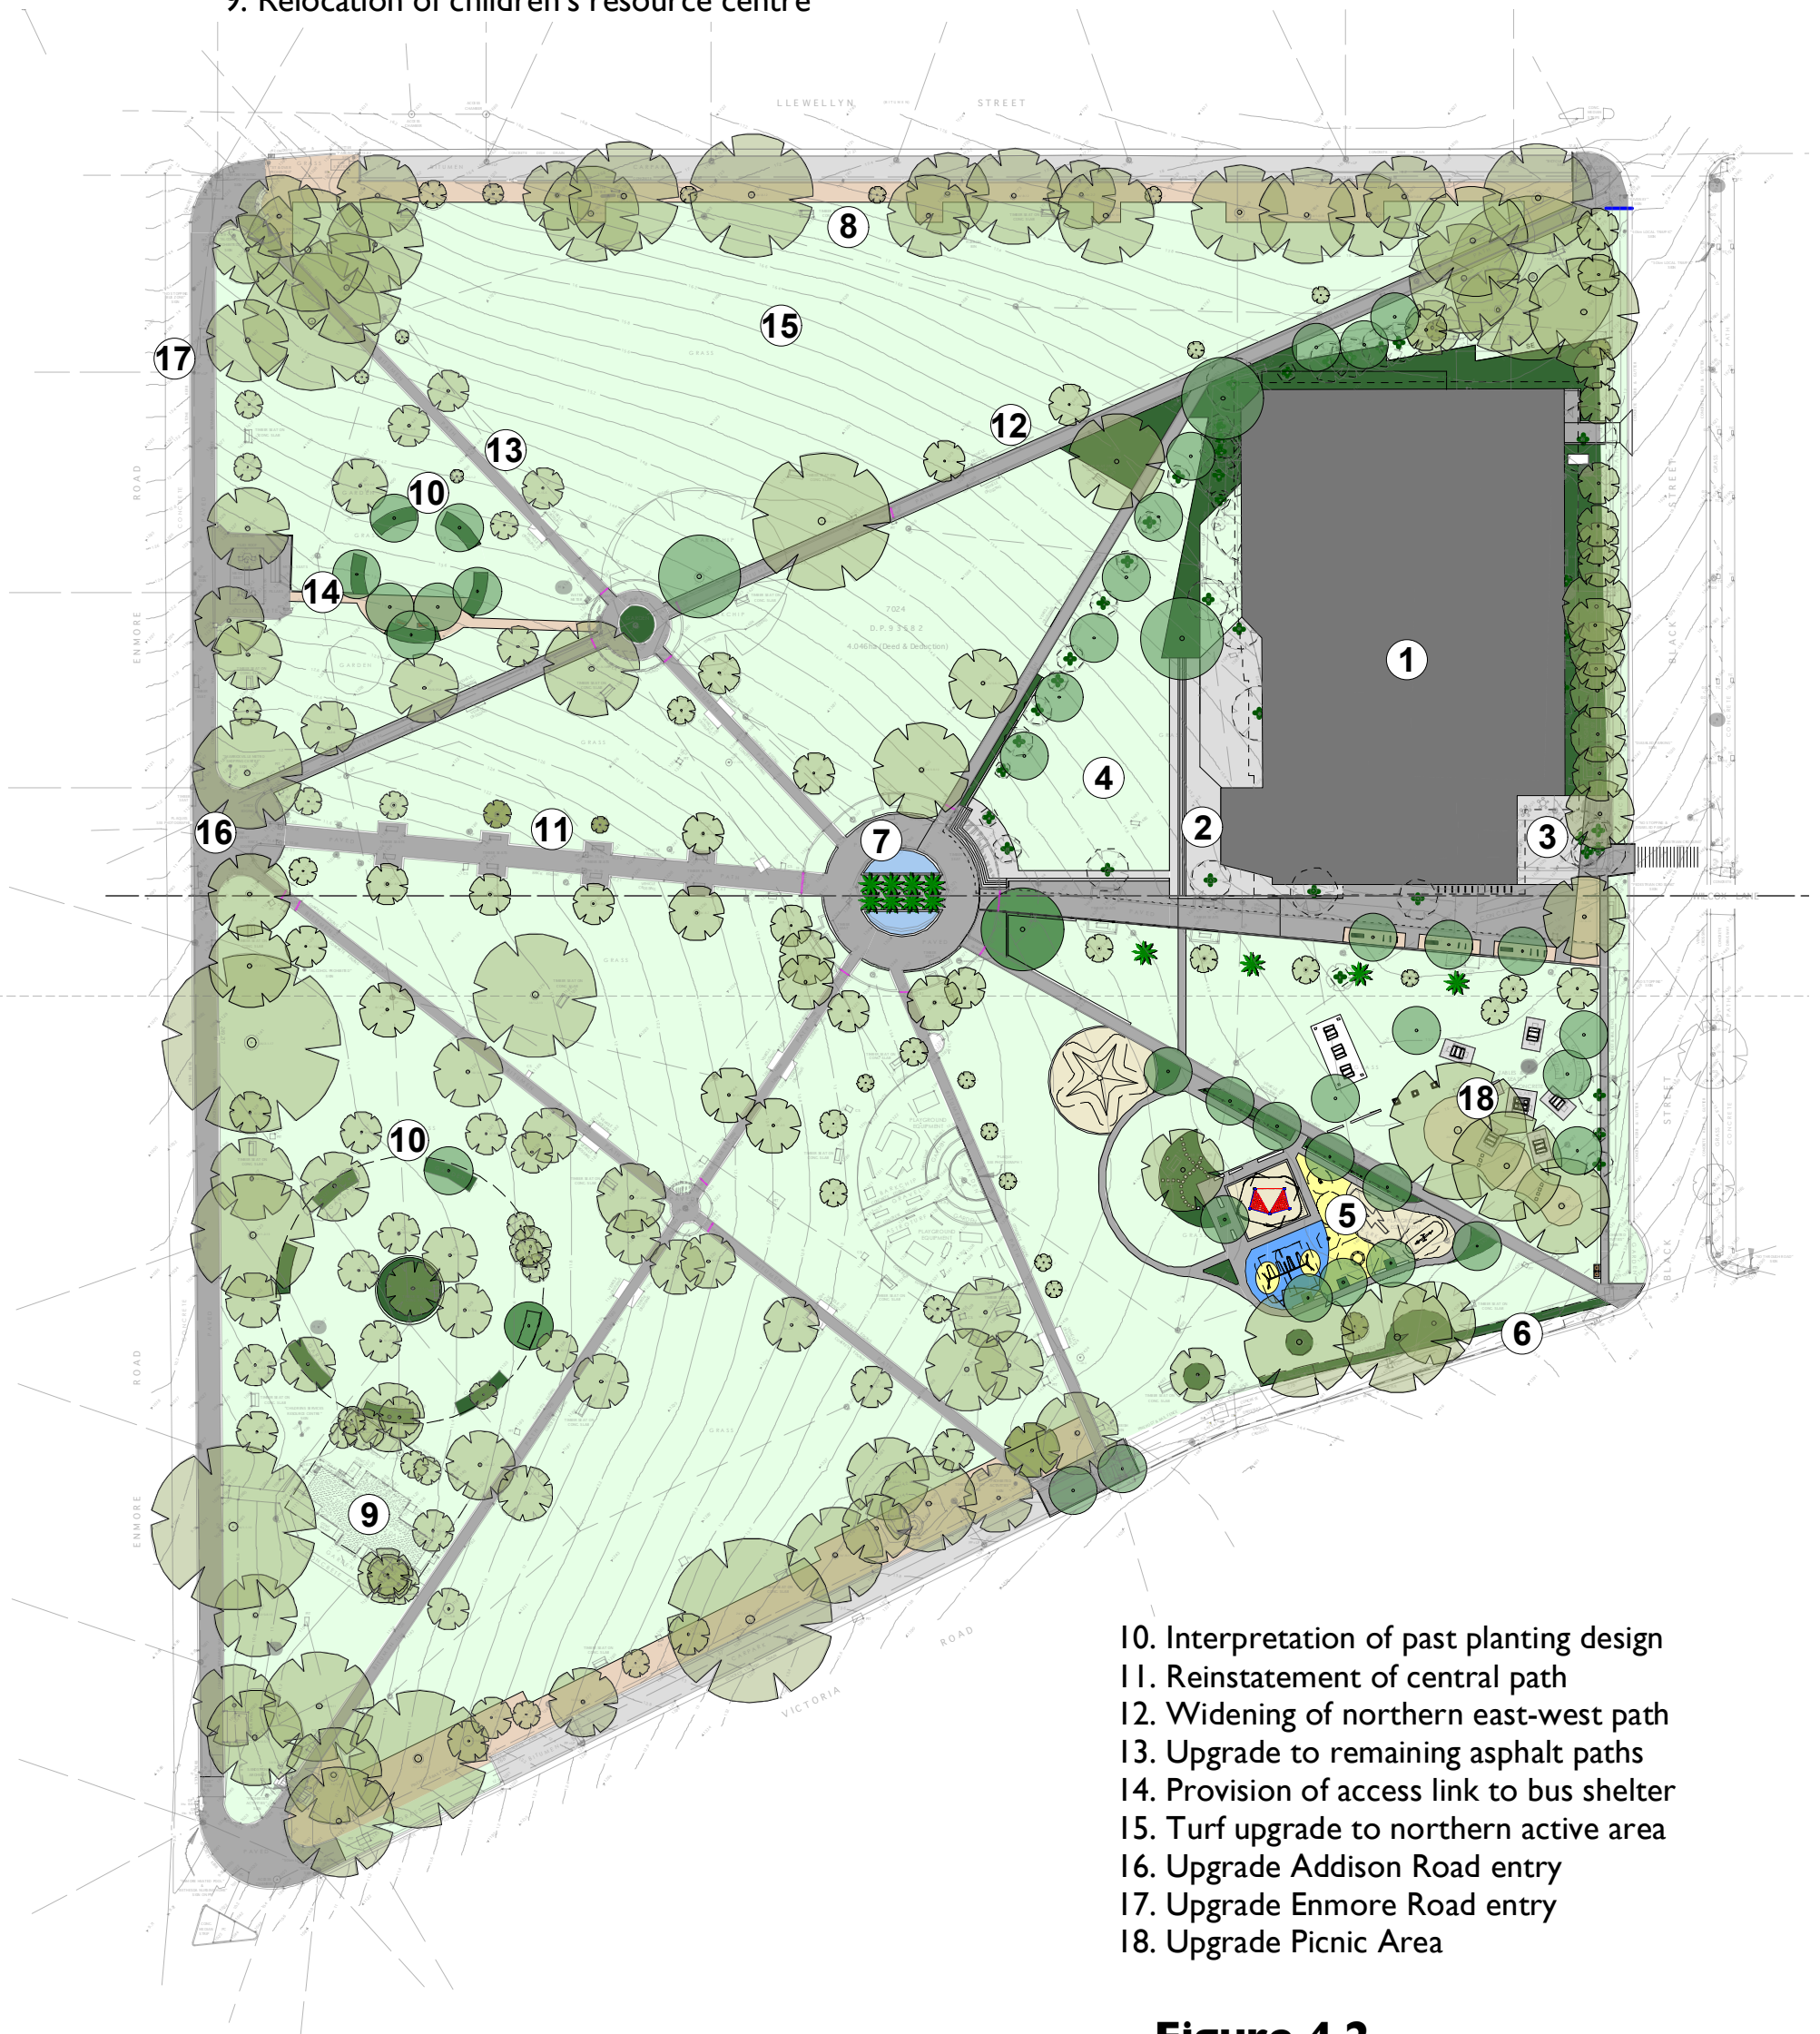
Figure 4.2
Masterplan

1. Pool complex redevelopment
2. Terrace
3. Landscaped pool entry forecourt
4. Grassed Terrace
5. Upgrade to rocket playspace
6. Improvements to Victoria Rd. frontage
7. Upgrade to central rondel
8. Llewellyn St. upgrade
9. Relocation of children's resource centre

10. Interpretation of past planting design
11. Reinstatement of central path
12. Widening of northern east-west path
13. Upgrade to remaining asphalt paths
14. Provision of access link to bus shelter
15. Turf upgrade to northern active area
16. Upgrade Addison Road entry
17. Upgrade Enmore Road entry
18. Upgrade Picnic Area

The Concept Masterplan is the culmination of potentially three phases of park upgrading, itself representing Phase Three – Long Term (refer Figure 4.2).

Figure 4.2 on the following page describes the preferred masterplan strategies identified in implementation of the detailed planning policies.

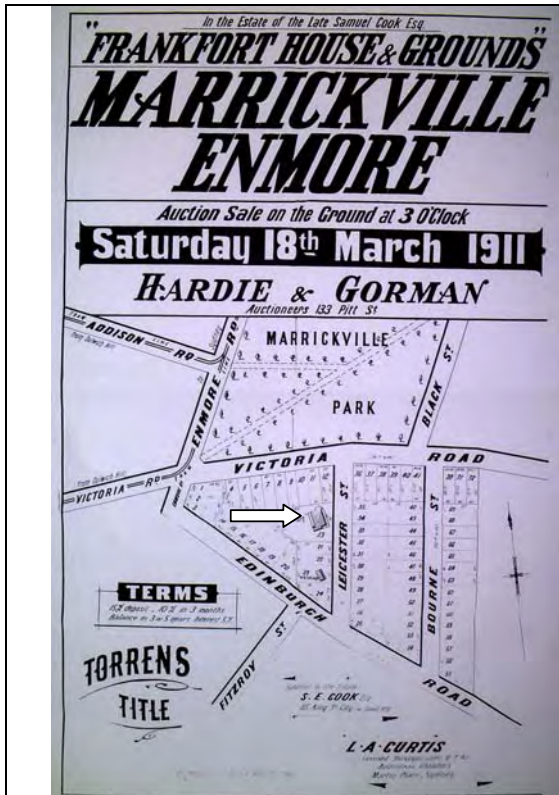
Figure H3 – 1911 subdivision plan for the *Frankfort Estate*, showing Enmore Park (then Marrickville Park) with two paths, one from the Addison Rd entry and one extending NE/SW across the park. This representation of paths may have been indicative only. Source: Marrickville local history centre (aperture card).

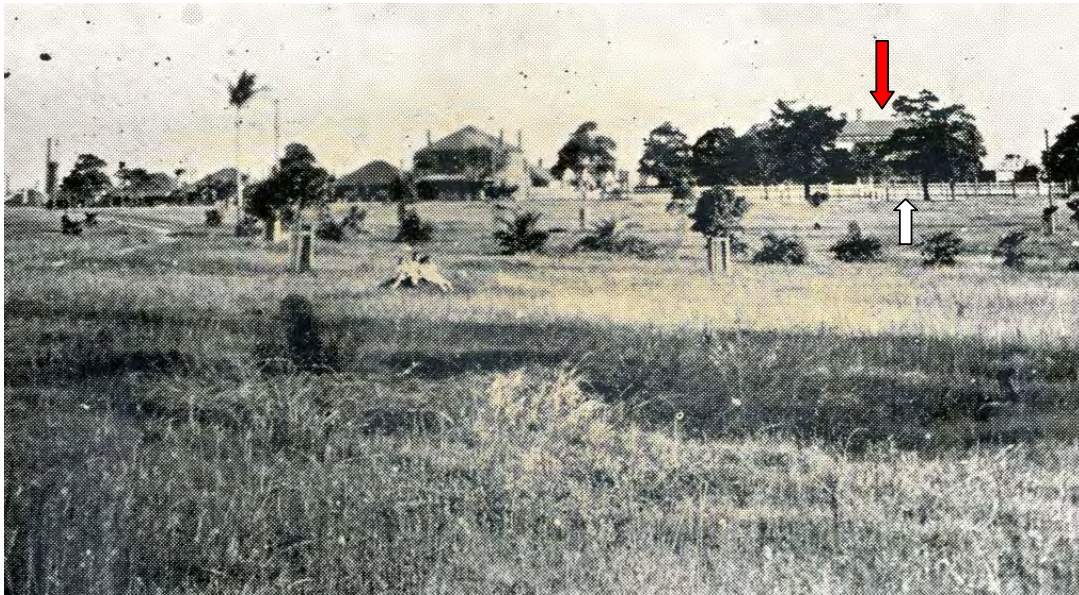
Figure H7 Photo from c.1922 looking south-east through the park, showing the park's central feature marked by the tall palm and the young Phoenix palms (extending across the photo at centre) planted along the path from Enmore Road. It would seem that the large bandstand was not built by the time this photograph was taken. The arrow shows the perimeter fence around the park.
Source: Marrickville local history centre.

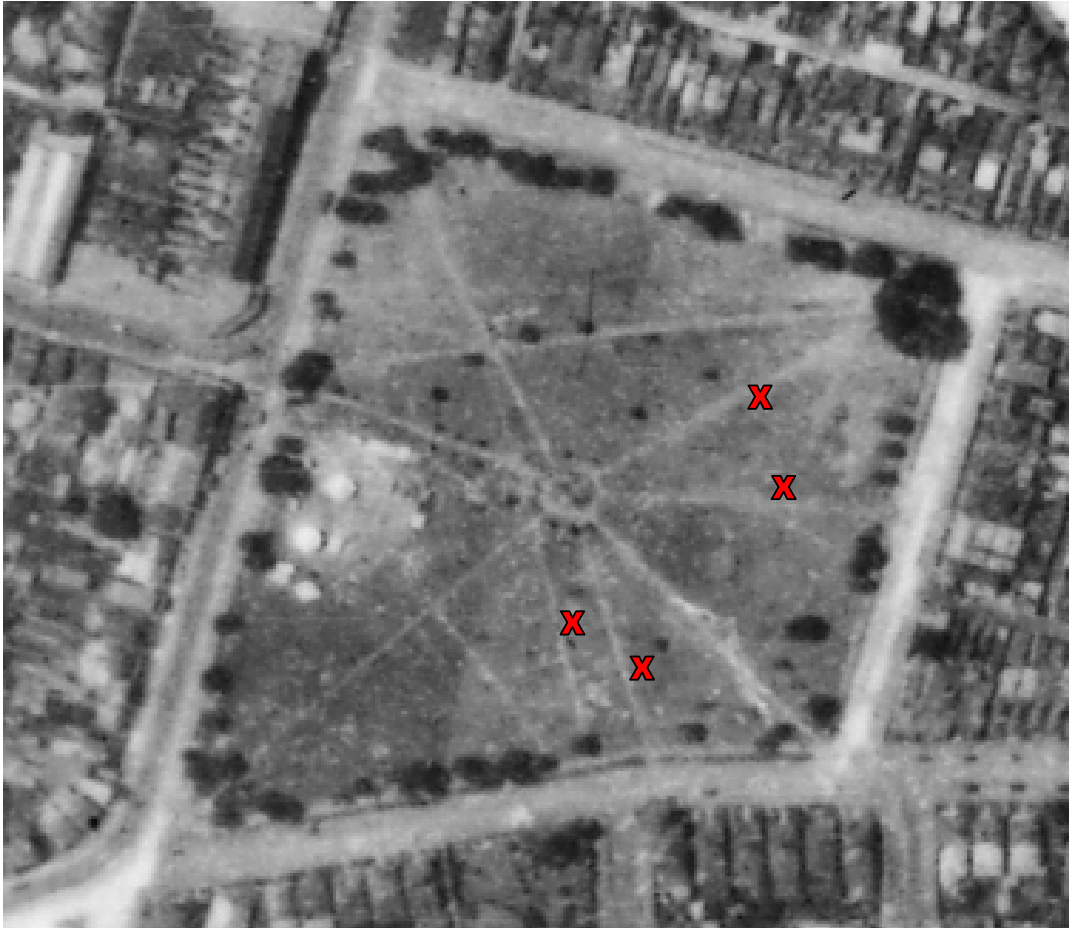
Figure H8 – Aerial photograph from 1930, showing marked with red crosses those pathways or desire lines through the park which no longer remain. However, the access provided by these removed tracks was retained by new paths laid out in similar locations in subsequent decades. There appears to be no bandstand at the centre of the park at this time. Source: Marrickville Council.

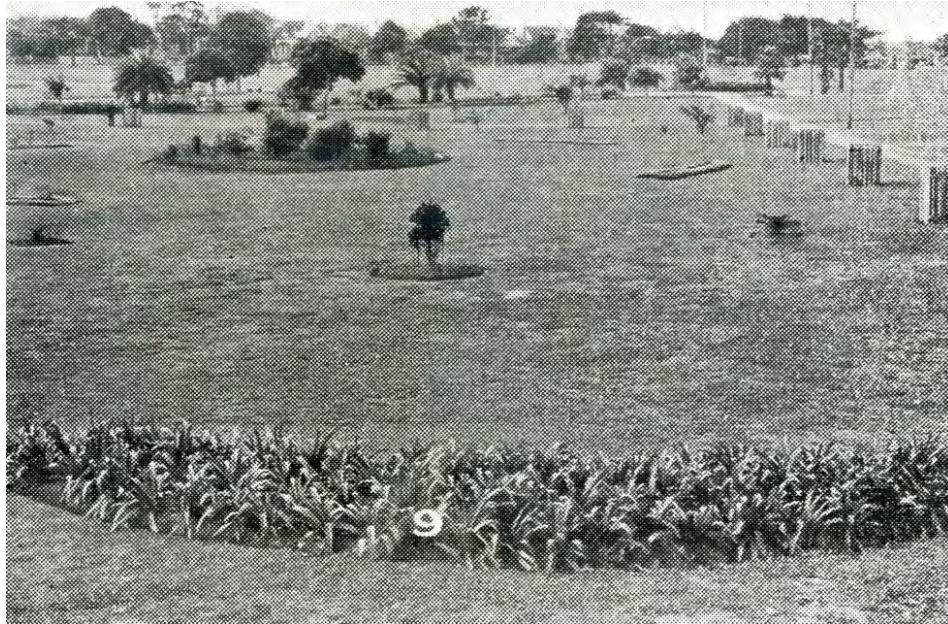
Figure H9 – Photo from c. early 1940s looking toward the park’s central circle from the south-west corner of the park near the children’s care facility. The circular configuration of island garden beds in the foreground and plantings along the path at right were made as part of the beautification works in the mid 1930s. Some of these garden beds have been retained. Source: Marrickville local history centre.

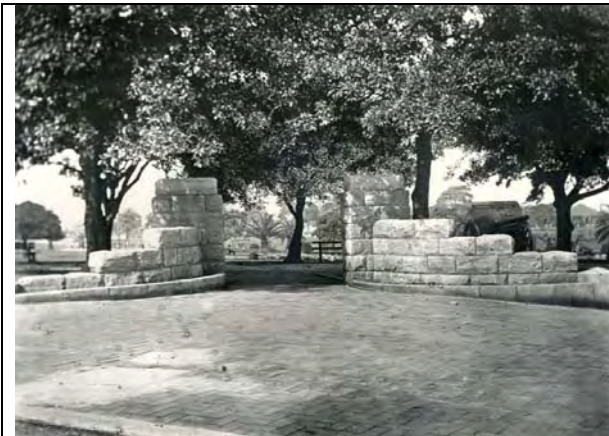
Figure H10 – c. late 1930s or early 1940s, showing the recently built sandstone entry gateway on the corner of Llewellyn Street and Enmore Road. The similar gateway and archway on the corner of Victoria Street and Enmore Road was constructed at the same time. Source: Marrickville local history centre.

In 1937, a sum of £500 was allocated towards the construction of two stone entrances to the park and stonework for a tram shelter. These were constructed, partly using relief labour, between 1937 and 1938, the gateways still remaining in their original configuration⁶.

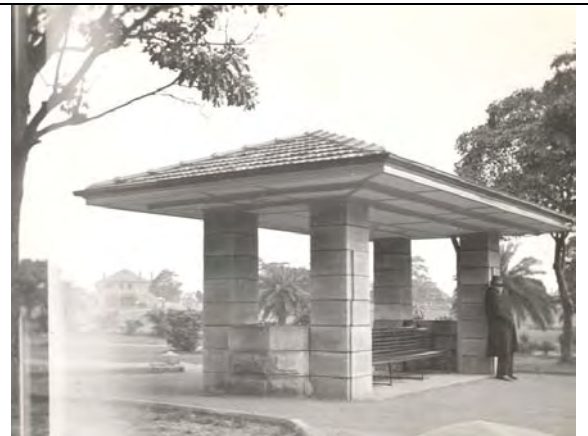
Figure H11 – Photo from c. late 1930s of the bus shelter on Enmore Road. The structure appears to have been little changed since that time. However, a path that led to the eastern side of the shelter from within the park, which existed since at least 1942, was removed after 1970. Low sandstone markers remain which identify where that pathway met the paved surrounds of the shelter. Source: Marrickville local history centre.

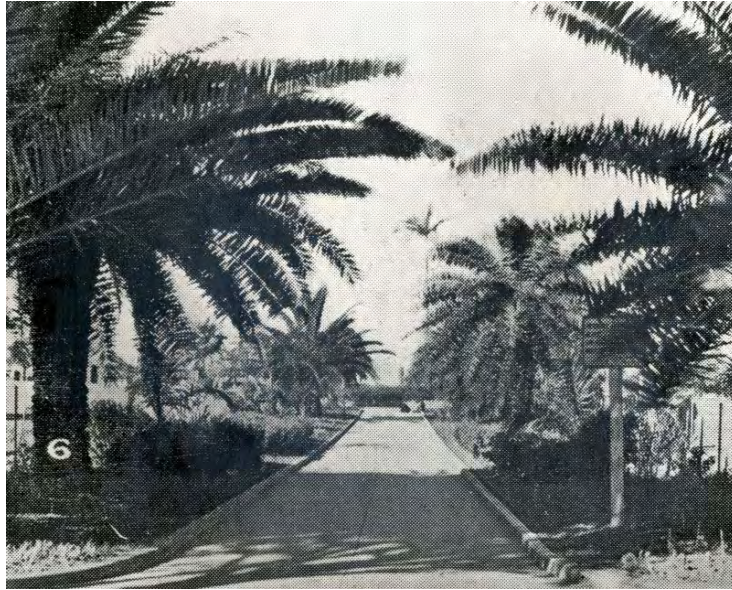
Figure H12 – Photo from c. late 1930s looking east up the main entry pathway from Enmore Road, with the Phoenix palms lining the path. These palms were removed c. early 1950s. No bandstand is apparent at the end of this pathway. Source: Marrickville local history centre.

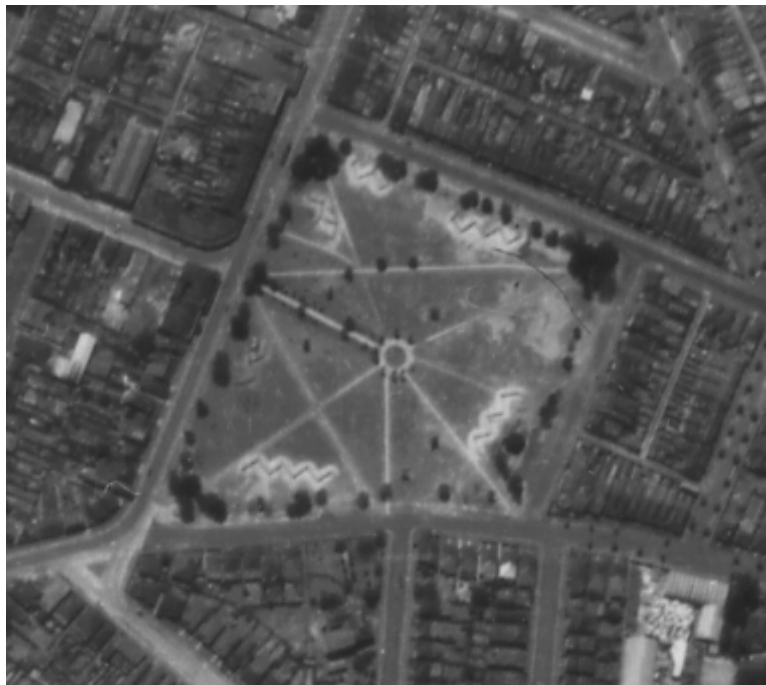
Figure H13 – Aerial photo from 1942 showing the formalised path network through the park and the zig-zagging elements referred to above. Source: Marrickville Council.

By 1942, the overall composition of the park was little changed from its configuration in 1930. Aerial photographic evidence suggests that the key paths through the park had been formalised and possibly resurfaced from their state prior to the 1930s upgrading works. Plantings made as part of these improvement works had not become mature enough to appear on the 1942 aerial image. Of most interest from the 1940s period of the park's development were the zig-zaged lines seen located around the park's boundaries. This overview has not confirmed what these elements were, but as they seem to have been removed by 1951, it is likely that they were facilities or features built for WWII purposes.

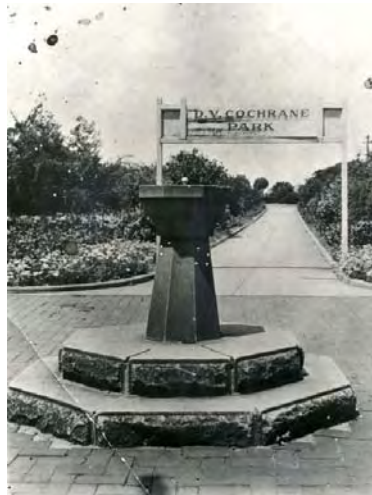
Figure H14 – c. late 1940s or early 1950s, showing the Enmore Road entry to the park. Note that the rows of Phoenix palms which led up to the park's central circle from the late 1910s had been removed and replaced by mixed shrub borders. Source: Marrickville local history centre.

By the early 1950s, the Phoenix palms along the central Enmore Road entry to the park had been removed and replaced by mixed shrubberies, in line with the fashion for mixed shrub borders seen commonly in Sydney park and institutional gardening at that time. Planter bed features and pathway plantings made between the late 1930s and the early 1950s can be seen clearly on the below 1951 aerial photograph, most of these works being carried out near the Enmore Road frontage of the park.

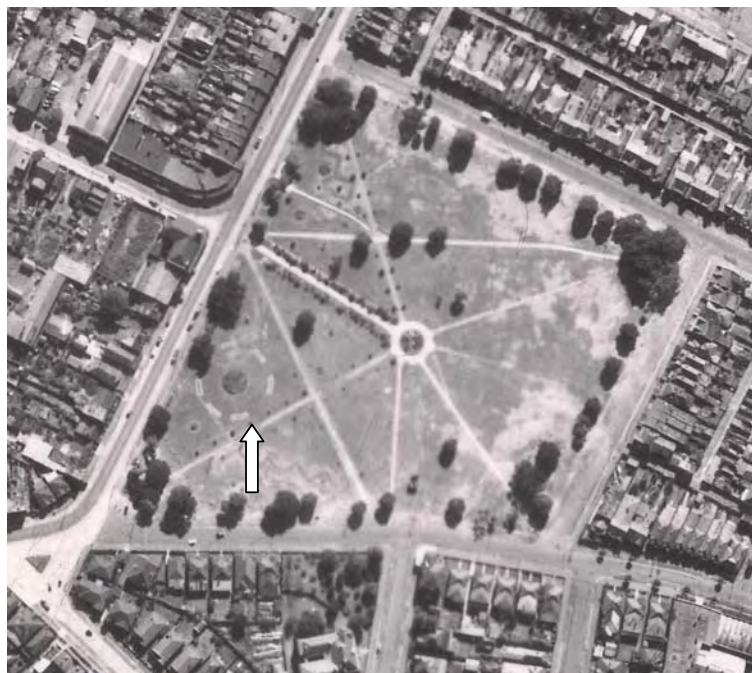
Figure H15 – Aerial photograph from 1951, showing the maturing plantings within the body of the site and the various planter bed zones adjoining Enmore Road. Note especially the circular planter sector (arrowed) near the south-west corner of the park. Source: Marrickville Council.

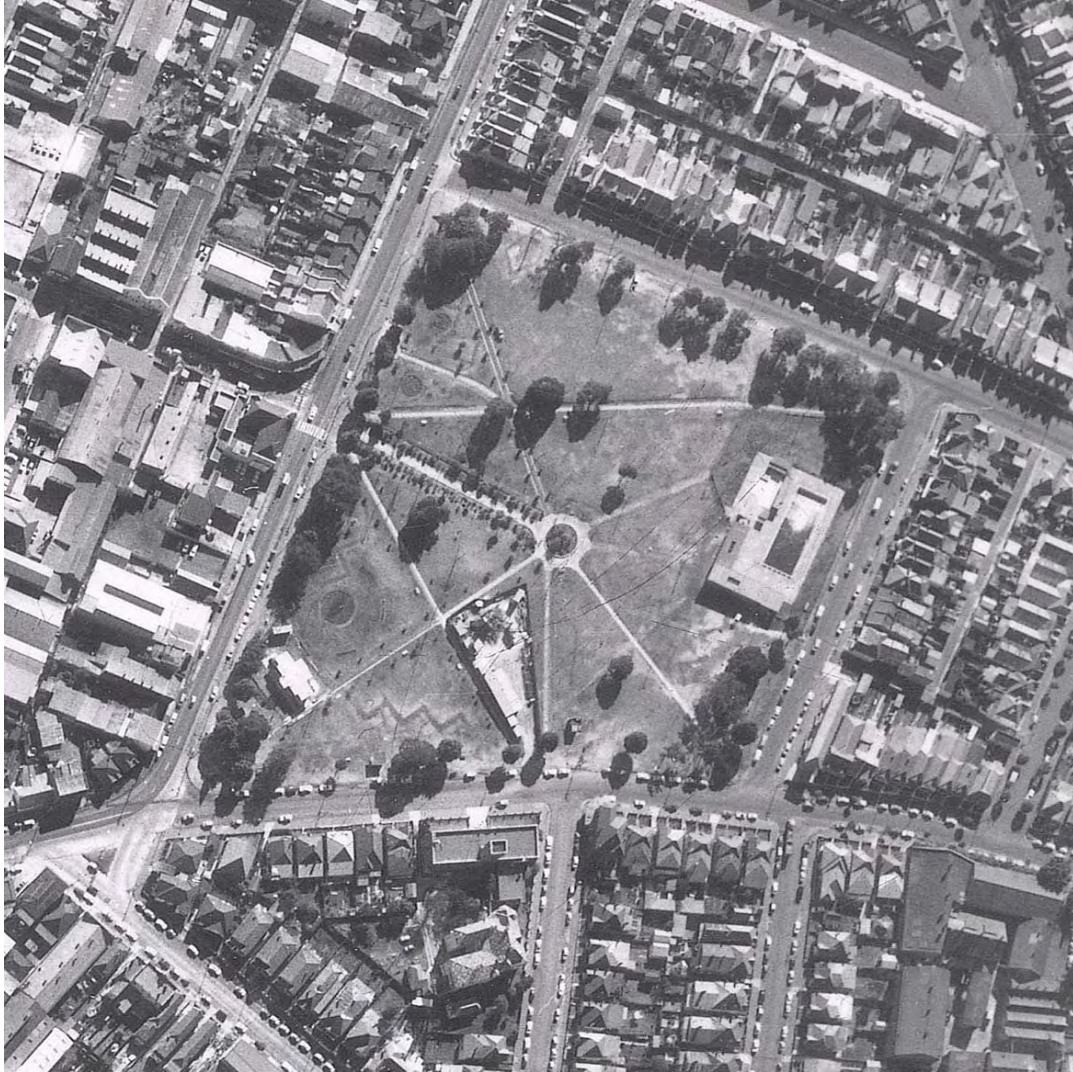
Figure H16 – Aerial photograph from 1970. Note that the footprint of the zig-zaging elements seen on the 1942 aerial can still be seen in the south-western corner of the park at this date. (Some portion of them remain identifiable even on current aeriels). Note also that much of the circular arrangement of planter beds near the childcare facility seems to have been downgraded, although the outline of the curved beds is just visible.

Several major works occurred in Enmore Park between 1951 and 1970, with the construction of the swimming complex, the use of a large triangular southern quadrant of the park for an as yet unknown facility [oral history should be able to ascertain this] and the construction of the child care building in the park's south-west corner. The path network by this date remained much the same as that which existed prior to 1930; however, the path extending to the park's centre along the southern side of the pool complex was not built by 1970.

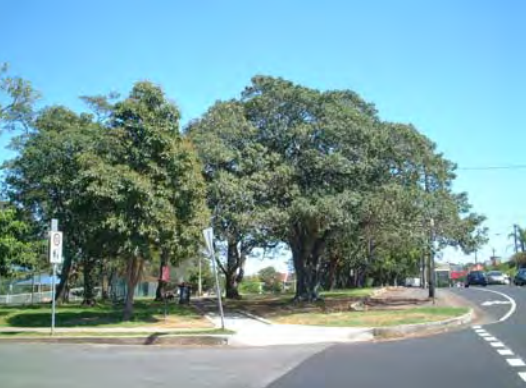
No.	Item and Location / Description of Historic Elements	Photograph of Item	Heritage rating, comment and/or heritage recommendations
11.	<p>Fig trees on the corner of Llewellyn and Black Streets</p> <p>The canopies of this grove of Fig trees appears quite substantial on the 1930 aerial photo of the site.</p>

<p>Rating: High (not for later infill plantings)</p> <p>Should be conserved and maintained by a skilled arborist.</p> <p>New plantings along this boundary could be considered between existing plantings to increase the park's boundary definition. Selected plantings should match existing mature species.</p>

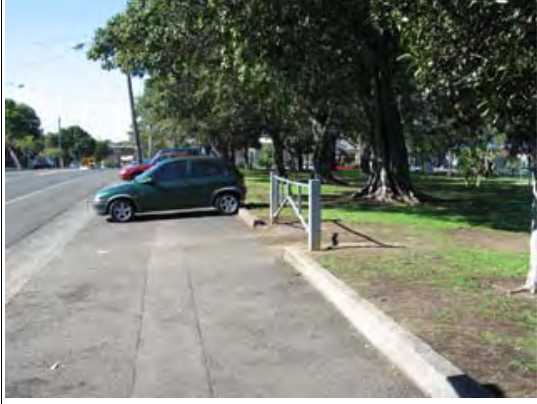
<p>11a.</p>	<p>Trees along Llewellyn Street A staggered line of mostly Fig trees along the northern boundary of the park which appear semi-mature on the 1930 site aerial photo.</p>

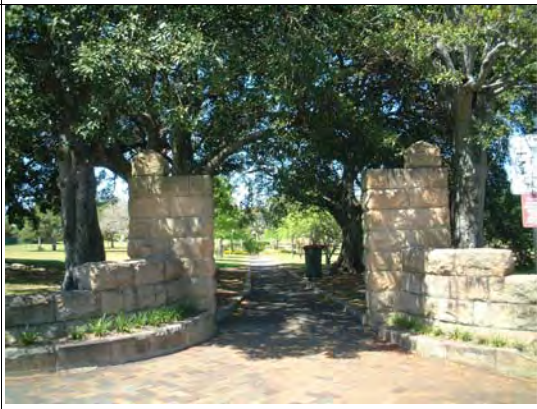
<p>Rating: Moderate – High Should be conserved and maintained by a skilled arborist.</p>
<p>12</p>	<p>Fig trees on the corner of Llewellyn Street and Enmore Road This grove of Fig trees appears semi-mature on the 1930 site aerial photo. As this was always a key entry to the park, these plantings would have been installed early in the park’s history to define the access point.</p>

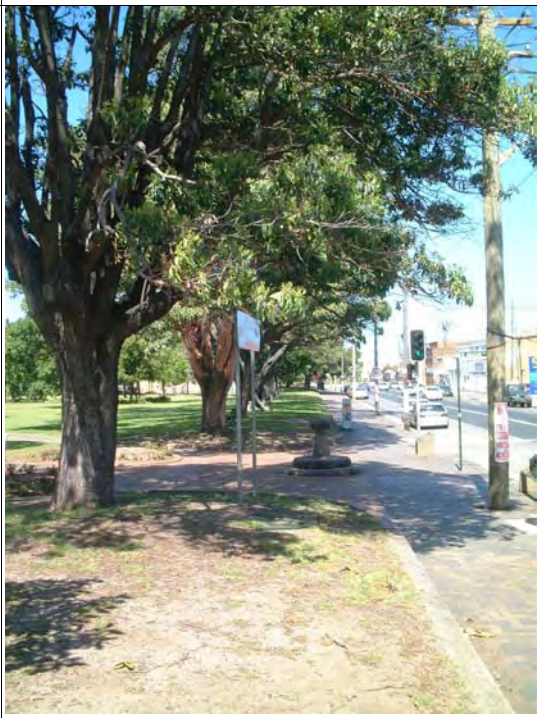
<p>Rating: Moderate - High (not for later infill plantings) Should be conserved and maintained by a skilled arborist.</p>
<p>13.</p>	<p>Fig trees and Brush Box along the park’s Enmore Road frontage Some of the Brush Box and Fig plantings along Enmore Road appear as mature trees in photos of this side of the park from the late 1930s. Whilst the plantings form a relatively consistent line along the Enmore Road frontage, it is clear that they were not planted in a formal, consistently spaced alignment.</p>

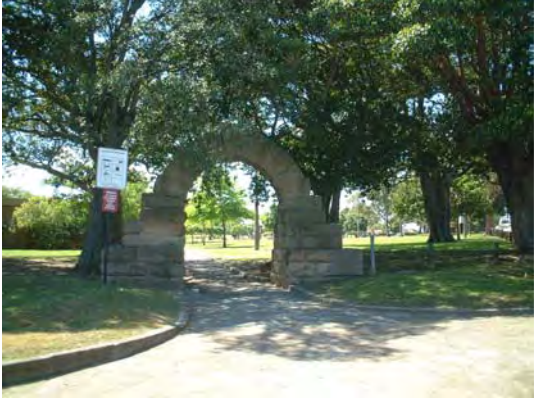
<p>14.</p>	<p>Fig trees and Brush Box around the park's south-western corner</p> <p>This grove of trees appears semi-mature on the 1930 site aerial photo. As this was always a key entry and view into the park for people approaching Enmore from the south, these plantings would have been installed early in the park's history to define the access point.</p>

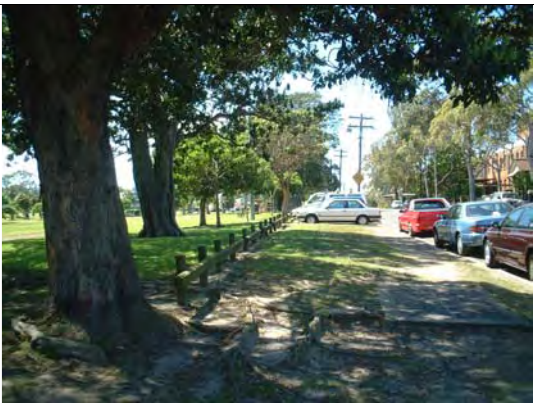
<p>Rating: Moderate - High (not for later infill plantings)</p> <p>Should be conserved and maintained by a skilled arborist.</p>
<p>15.</p>	<p>Fig trees, Brush Box and other species fronting Victoria Road</p> <p>The inconsistently spaced and aligned frontage of trees to Victoria Road contains a mix of species planted throughout the last hundred years.</p> <p>In 1930, the largest of the trees along this side of the park were opposite the home garden of the former <i>Frankfort House</i>.</p>

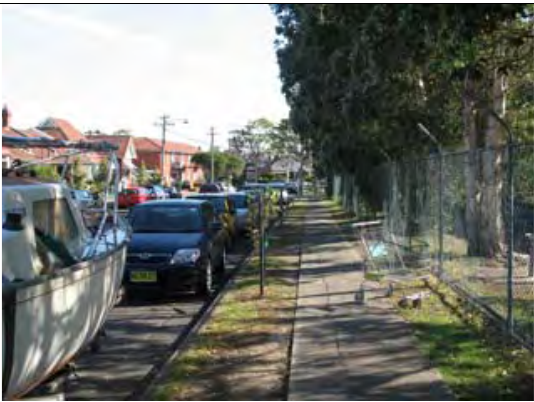
<p>16.</p>	<p>Paperbarks along the Black Street boundary</p> <p>The existing row of Melaleucas along the eastern façade of the pool complex were planted after 1970 and have no heritage value.</p>

<p>Rating: None (for plantings adjoining pool complex)</p> <p>New plantings along the southern section of this eastern boundary could be considered between existing plantings to increase the park's boundary definition. Selected plantings should match existing mature species, principally Figs and Brush Box.</p>

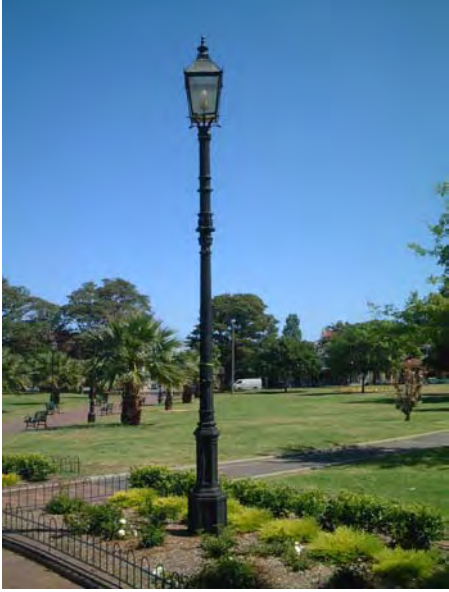
<p>20.</p>	<p>Light poles</p> <p>Further research would be needed to identify the installation date of the existing period lightpoles in the park, but this may not be warranted.</p> <p>Available historic photos collected to date do not show these lightpoles; however a photograph from the late 1930s or early 1940s seems to indicate that there were different lightpoles in the park at that time.</p>

<p>Rating: Not known</p> <p>Until more is known about their provenance, it is difficult to ascribe a heritage rating to them.</p> <p>They have an Edwardian period style which would have suited the Park in the early 20th century, although they may have been brought in from elsewhere and installed later.</p> <p>It is suggested they be grouped into one precinct of the Park – e.g. near the Enmore Road entrance, and that other, modern lighting be installed in the remainder of the Park.</p>
<p>21.</p>	<p>North-western entry gateway</p> <p>This sandstone gateway from the corner of Llewellyn St and Enmore Rd was built in the late 1930s as part of a substantial upgrading of the park.</p> <p>It appears to have been retained in its original form, although the two blocks at the top of each ‘pillar’ were not present in the photo of the item taken after its completion.</p> <p>The brick paving in front of the element may date back to its construction, when brick edging was seen around this street corner.</p>

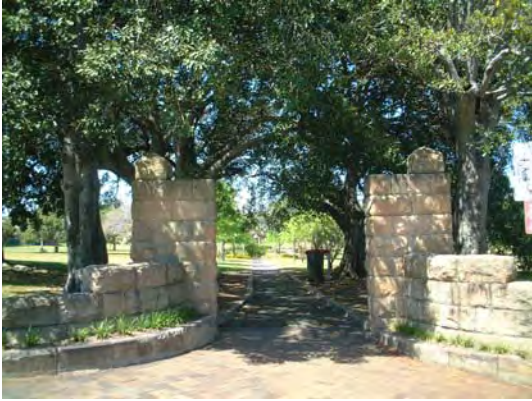
<p>Rating: High</p> <p>Retain as existing. Confirm original location of two blocks on the top of the gateway.</p> <p>Repair damaged sections as required and as advised by a conservation architect.</p>

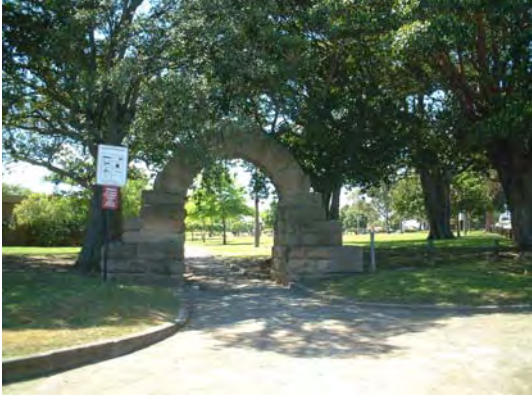
<p>22.</p>	<p>South-western entry archway</p> <p>This sandstone archway from the corner of Enmore Rd and Victoria Rd was built in the late 1930s as part of a substantial upgrading of the park.</p> <p>It appears to have been retained in its original form.</p>

<p>Rating: High</p> <p>Retain as existing. Confirm existing composition reflects original design and construction.</p> <p>Repair damaged sections as required and as advised by a conservation architect.</p>

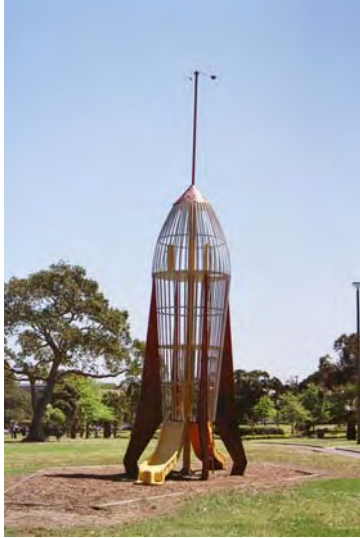
<p>32.</p>	<p>Children’s rocket</p> <p>The provenance of this has yet to be established, but it is typical of such elements built following the space race and the moon landing. It possibly dates from the late 1960s or early 1970s, but may have been upgraded since.</p> <p>It stands in splendid isolation away from seating, shade, or other play facilities.</p>

<p>Rating: Low</p> <p>Probably worth retaining as a good example of its type and one that is becoming increasingly rare.</p> <p>It warrants being integrated into a children’s play centre or near to a family barbecue facility.</p>
<p>33.</p>	<p>Central rondel – edging</p> <p>The original stone edging around the central rondel is just visible behind the later concrete ‘kerbing’.</p>

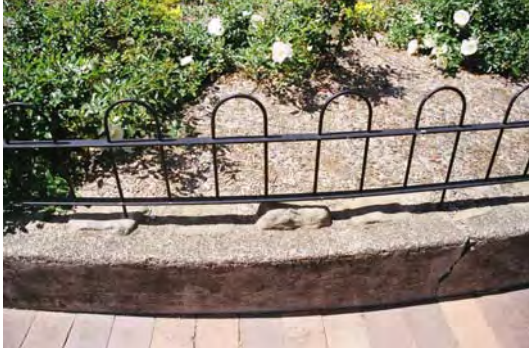
<p>Rating: Low</p> <p>Not particularly significant in itself but for marking the original edge of the rondel throughout perhaps nearly a century.</p> <p>While not an ideal solution aesthetically, this edging ought to be retained for historical interpretation purposes.</p>

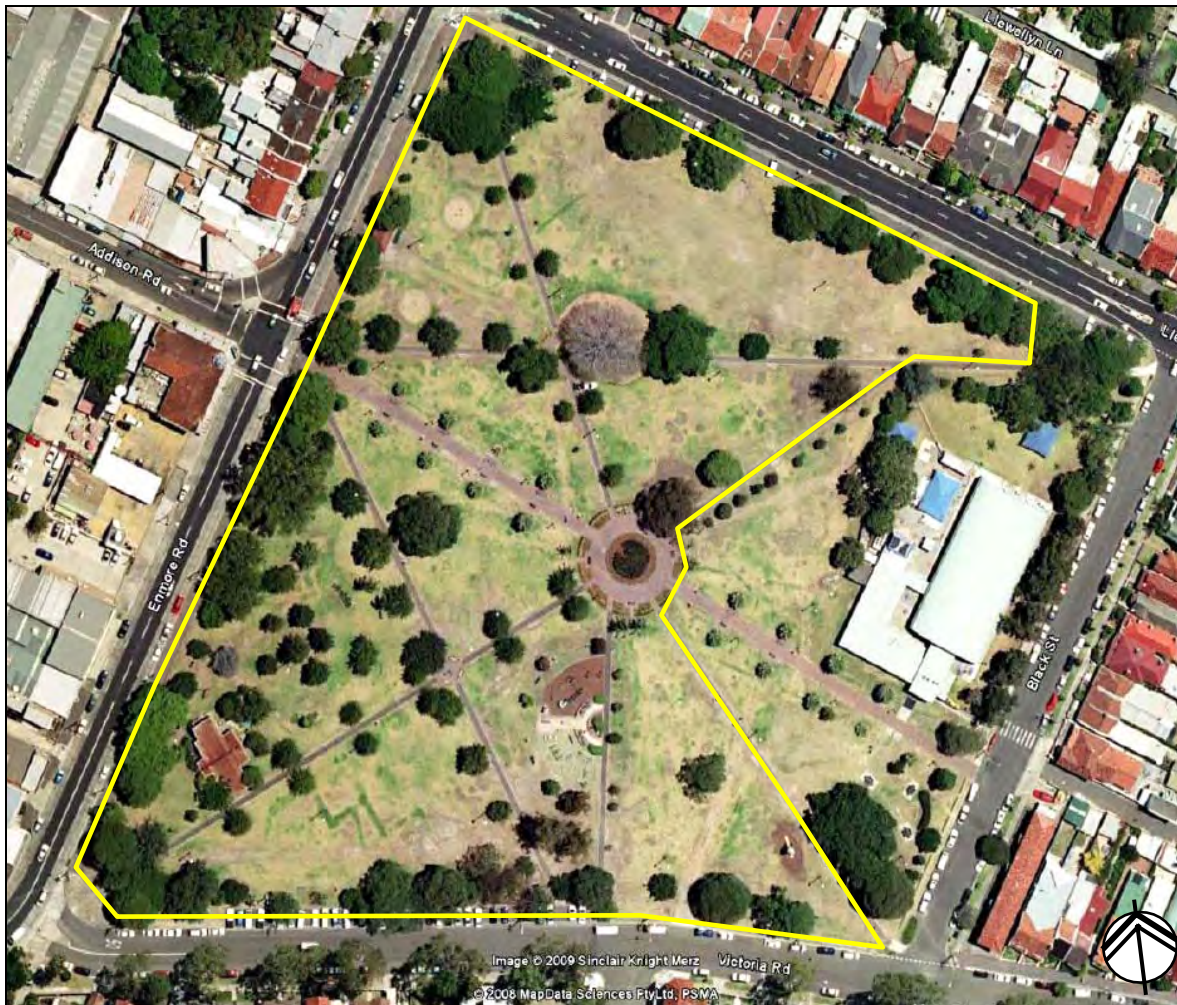
Figure 2
ENMORE PARK – AERIAL VIEW OF SUBJECT AREA
The trees inside the area bounded by the yellow, unbroken line are the subject of this report.

- 2.3** The trees assessed for this report are numbered from 92 to 250. The remaining ninety-one (91) trees were subject to a separate audit and development impact assessment and report prepared for the proposed re-development of the Annette Kellerman Aquatic centre. An aerial view of the site (Figure2) is on the following page.

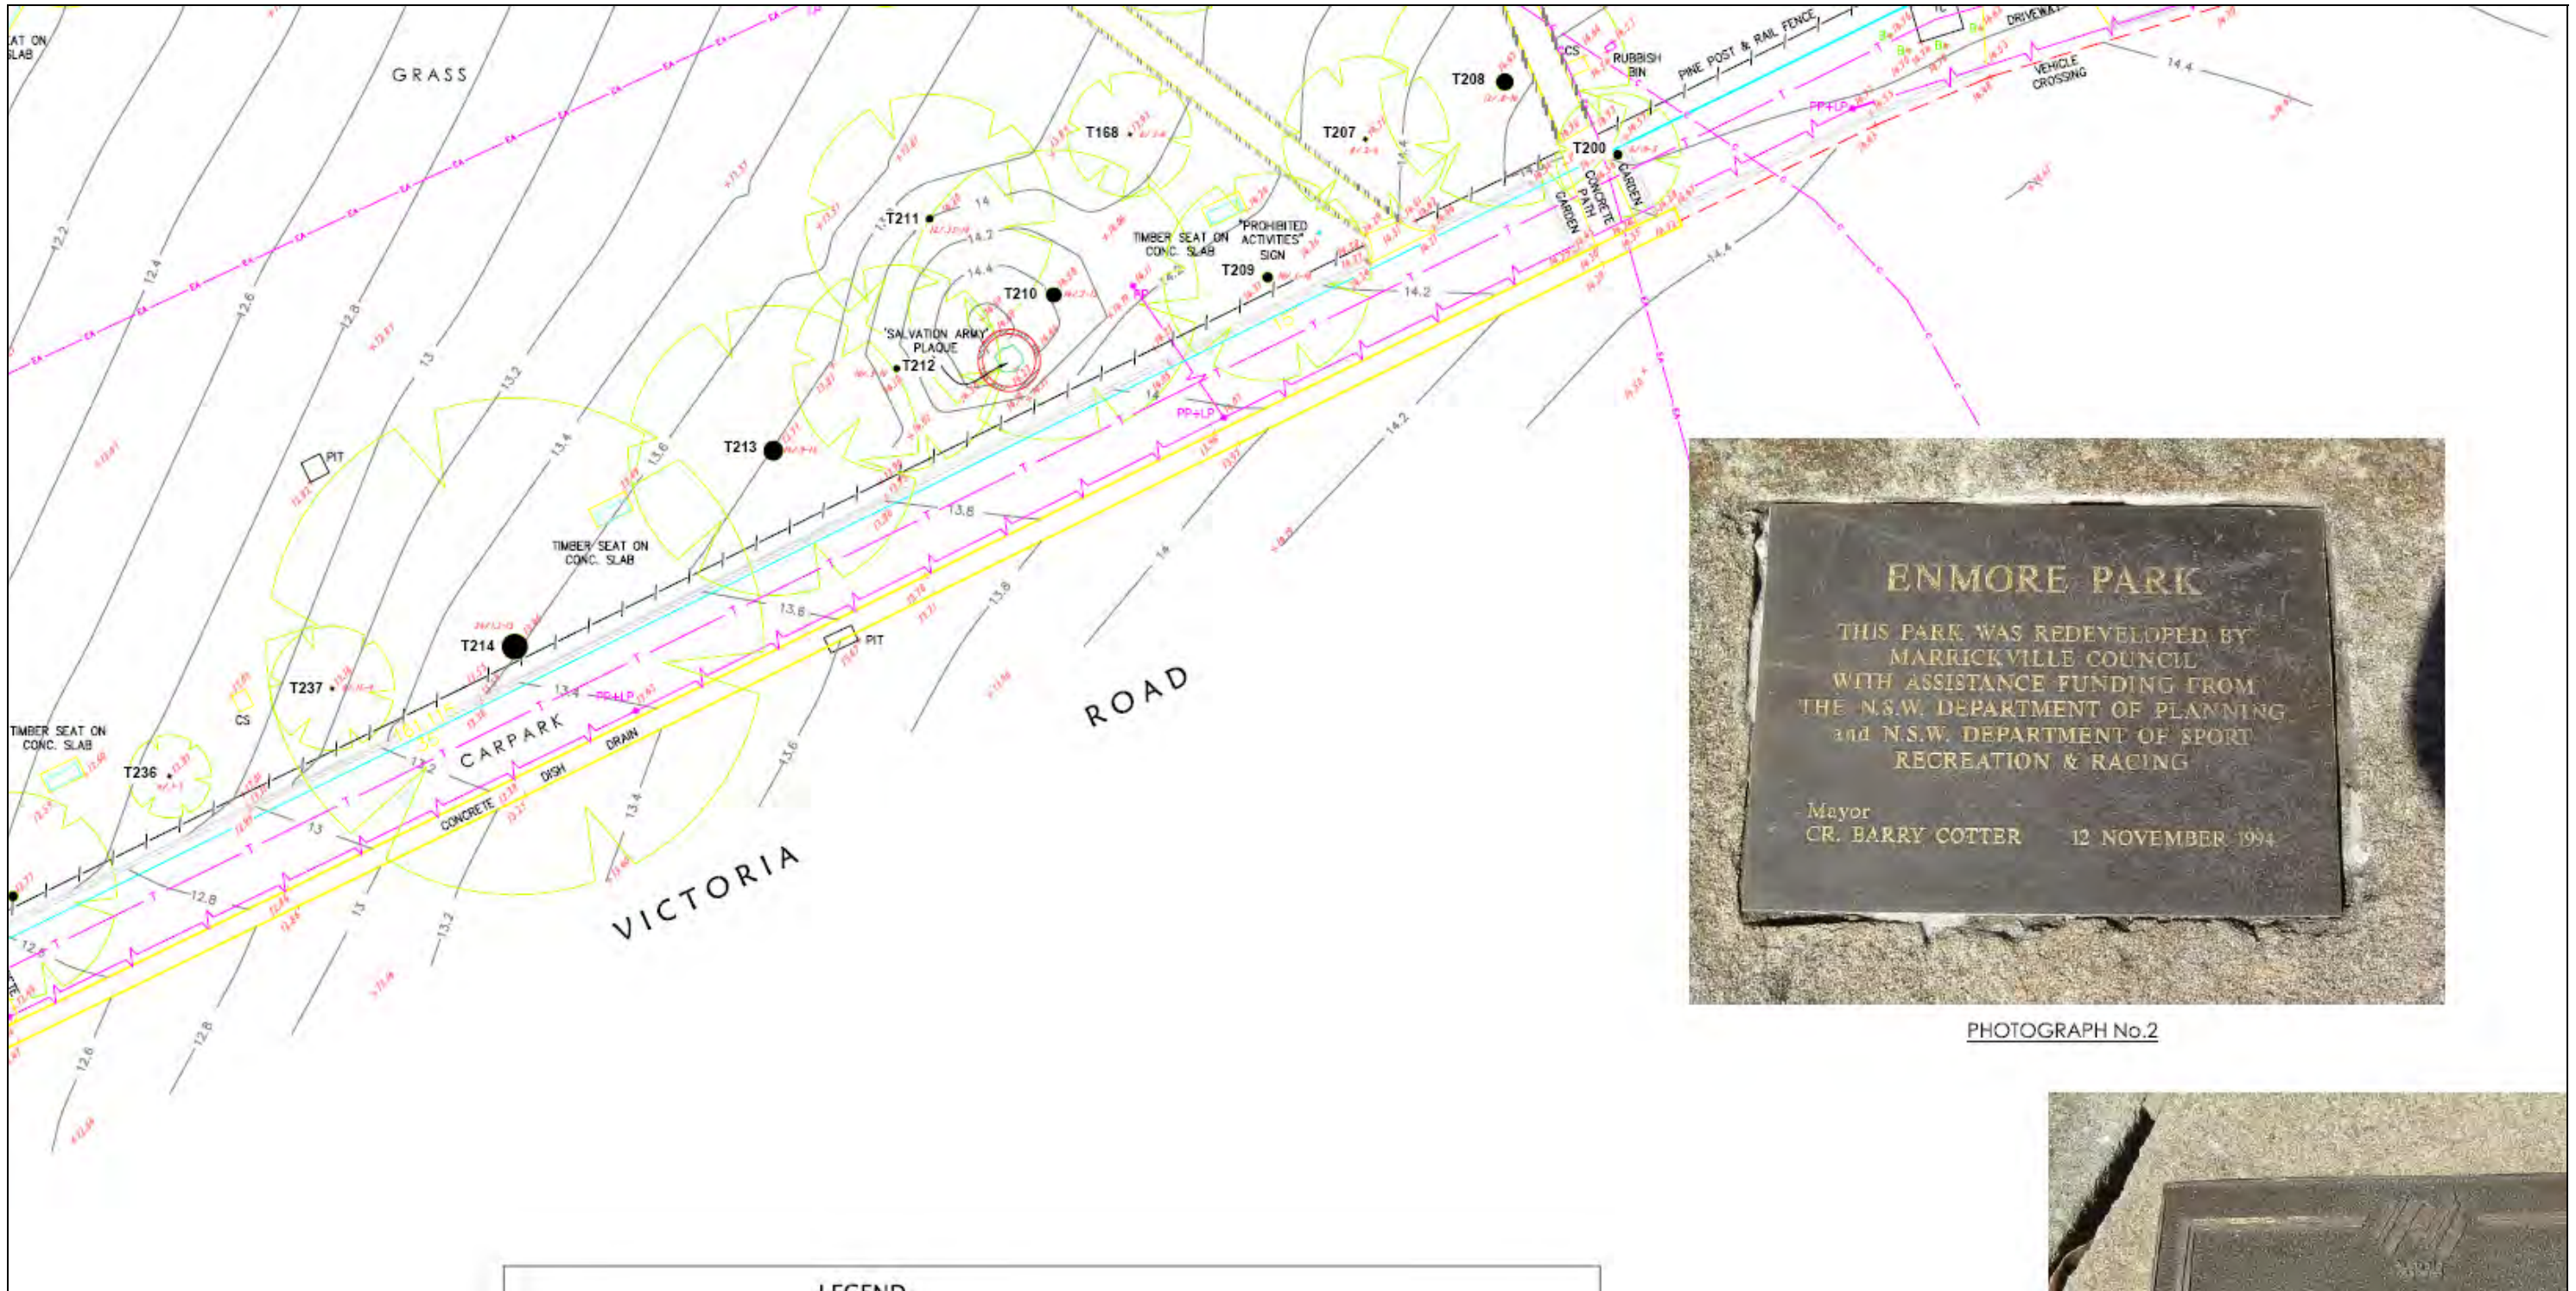
TREE LOCATION PLAN (PART)

Not to scale - refer to marked up copy of Sheet 2 of Detail Survey by Craig & Rhodes emailed 20/02/09 with this Arboricultural Assessment.

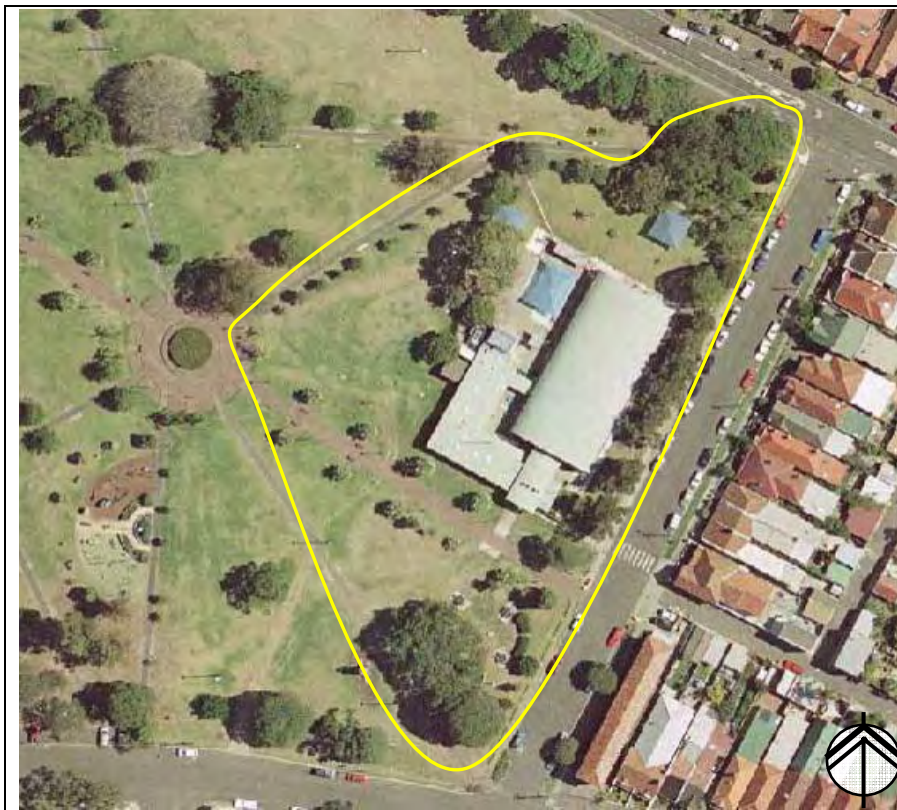
Figure 2
ENMORE PARK - LOCATION OF SUBJECT AREA
The trees within the area bounded by the yellow, unbroken line are the subject of this report.

- 1.7 The Development Impact component of this report assesses any identified or potential impacts that the proposed development may have on the subject trees. This report provides specific tree management and protection measures, and identifies trees that require further detailed arboricultural attention.
- 1.8 Information contained in this Arboricultural Assessment covers only the trees that were examined, and reflects the condition of those trees at the time of inspection. The area subject to the arboriculturist assessment and development impact report is a portion of the existing Enmore Park and Annette Kellerman Aquatic centre, as shown in Figure 2.

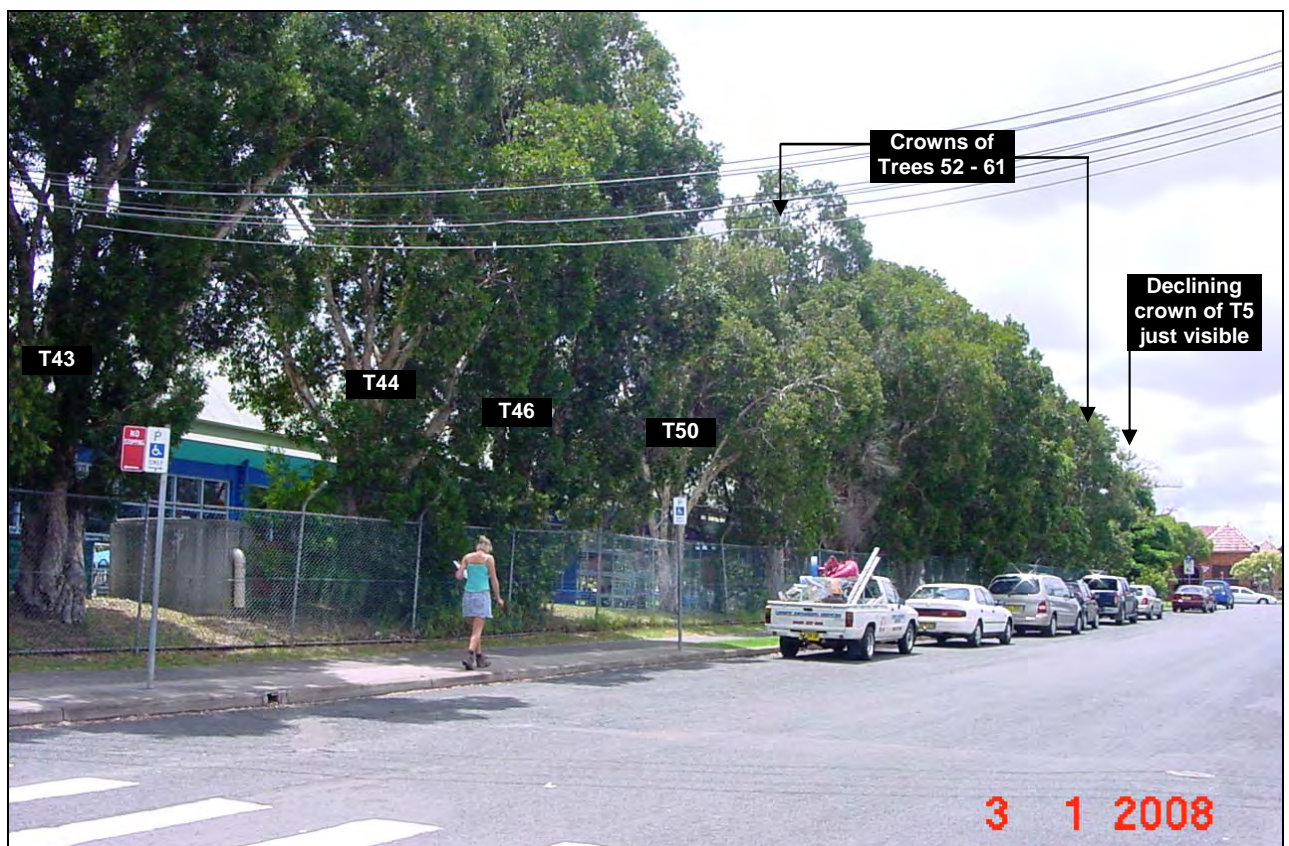
Plate 1

Although most of these trees are not individually significant, as a row of trees they contribute substantially to the landscape character of the street.

3.1.2 The plantings along the east boundary, facing Black Street, consist mainly of large, mature *Melaleuca quinquenervia* (Broad-leaved Paperbark), and a few mature Brush Boxes. Although these trees are not individually significant, or part of the original park planting, as a row of trees they provide substantial landscape screening and visual reduction of the current building and pool facilities, between the park and the street.
