Enmore Park

plan of management + masterplan

ENMORE PARK PLAN OF MANAGEMENT

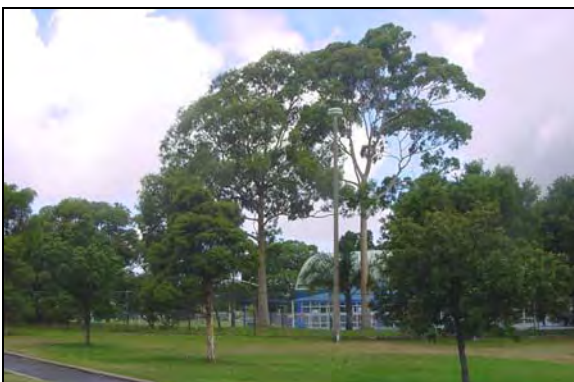
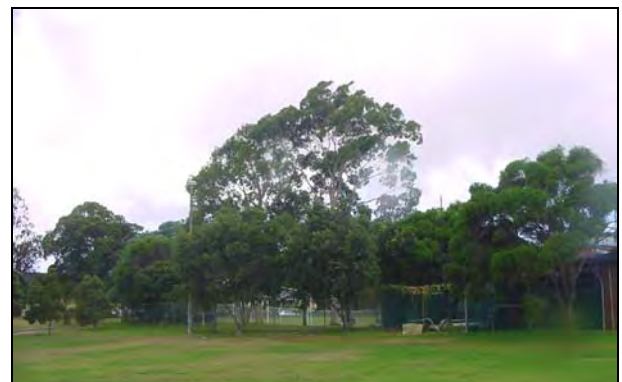
Plates 2 and 3

The tree height and crown spread of these two Lemon –scented Gums identifies these as significant park trees.

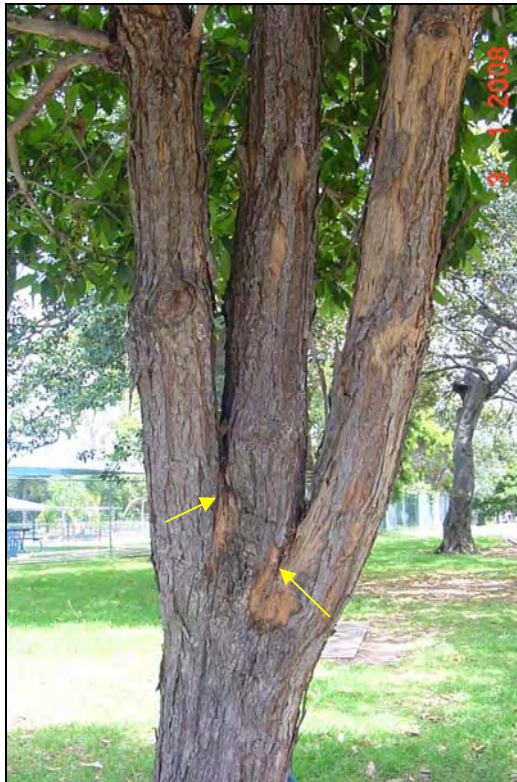
Plate 4

Three branches (actually secondary stems) arise at the same point of attachment to the main stem of the tree. The bark is *included*, and there are noticeable seams (arrowed).

3.2.2 Tree 3 is a semi-mature *Lophostemon confertus* (Brush Box), growing near the path at the northeast corner of Llewellyn and Black Streets. The tree is healthy and vigorous, but has a poorly developed branch structure, which presents an increasing risk of branch failure as it matures.

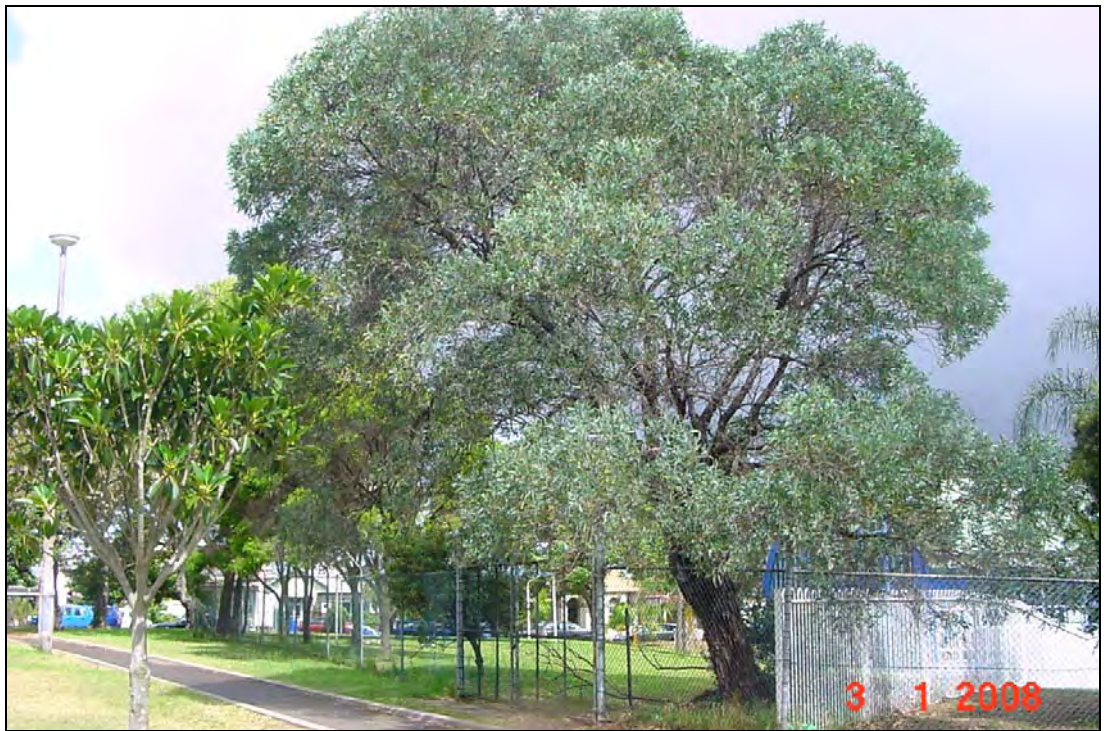
Plate 5

The above Coast Myall (silvery foliage) is a healthy specimen, with moderate landscape significance. However, the trees weight is over a public path and, given its maturity and short life span, is considered a high risk tree.

3.2.5 Tree 71 is an over-mature *Acacia binervia* (Coast Myall), which is still in good health, and relatively good condition. The dimensions of the tree are representative of a specimen at its ultimate mature size. Whilst the tree does not appear to present an immediate risk, the generally short lived nature of many of the *Acacia* genus, combined with a stem and crown leaning to the north over an existing path, identifies this tree as having a higher than normal risk of failure.

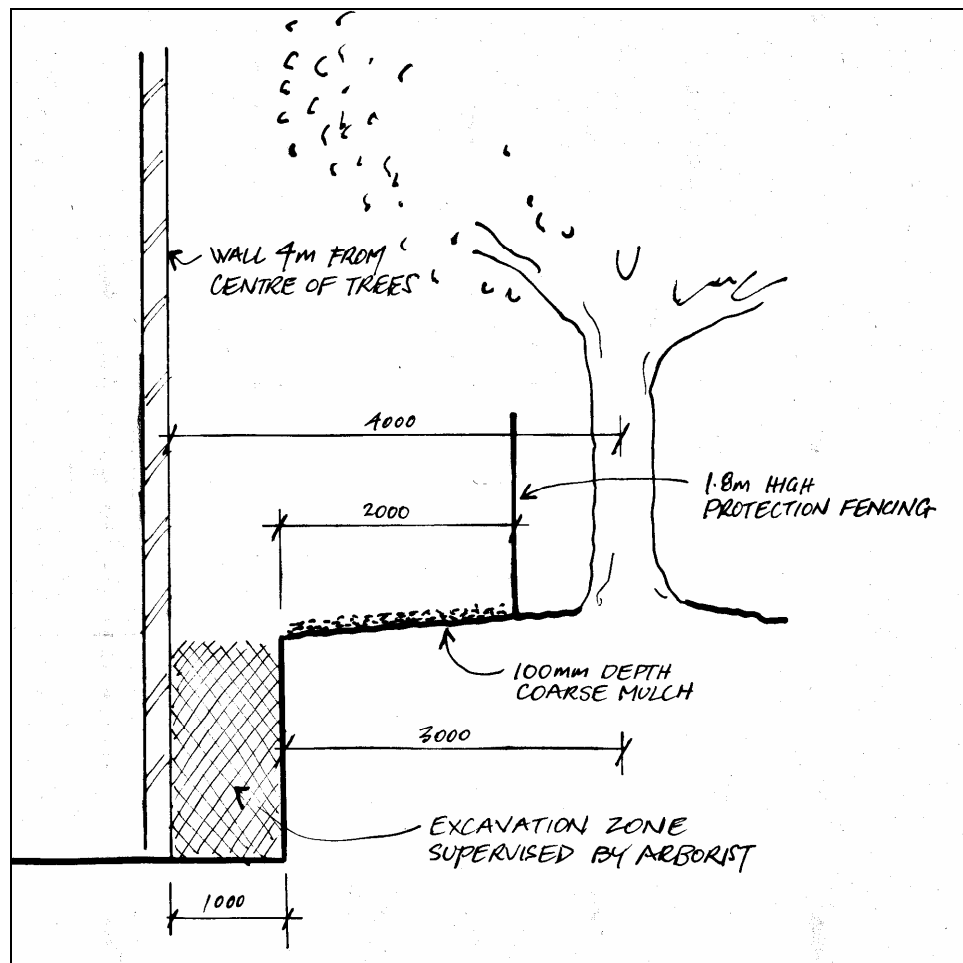
Figure 1 Protection of root zone, and arboriculturist supervision required for works adjacent to Paperbarks along the Black Street frontage of the subject site.

- The roofline of the proposed building is to be reduced to approximately 500mm width, where it would require excessive pruning of the trees. This is to be determined prior to finalising construction drawings.
- All works within 4 metres of the trees are to be supervised by an AQF 5 arboriculturist. This includes demolition of existing tanks, barbecues, underground and above ground utilities.
- Protection of these trees is to be in accordance with Figure 1, below.
Note: If any foot traffic is proposed over the mulched areas, timber planks or other similar sturdy material is to be placed and secured on top of the mulch. This timber walkway is to be maintained for the duration of construction.
- No machinery is to be used within the mulched areas.

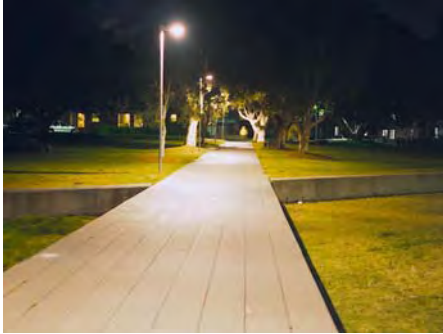
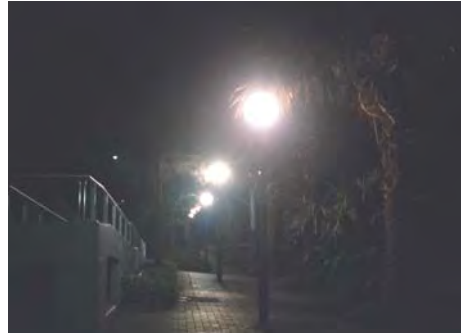
The photo on the left shows a path with high colour rendering lamps with good glare control while the installation on the right uses poor colour rendering lamps with louvers to provide some glare control. Note that you can see the person at the end of the path on the left. The left installation also uses less than half the energy of the installation on the right.

Glare - Glare is the relationship between the brightness of the light source and the background. In external lighting installations glare is more significant as the background is virtually black.

A glaring light source prevents people from seeing past the fitting so that their field of view is limited to the area within the lights. The effect is claustrophobic and reduces the feeling of safety for the person as they cannot tell if there is someone just beyond the lights.

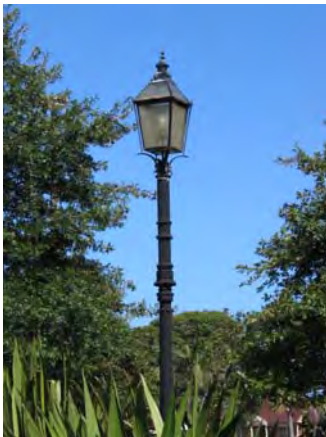
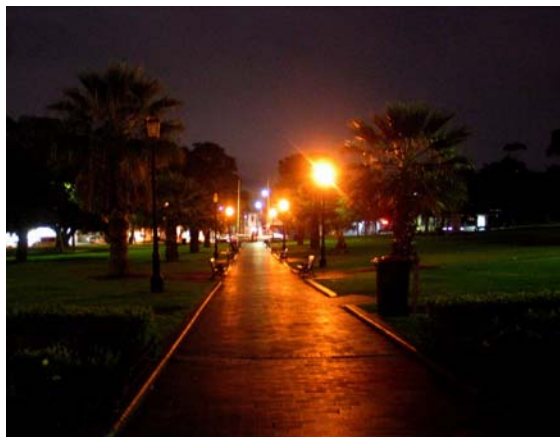
Note the glare and the poor visibility surrounding the path. These fittings do not have EnergyAustralia numbers and therefore are probably privately owned by the council.

This path appeared to be the principal route through the path at night, linking the houses on the eastern side of the park with the bus stop.

The central circle in the park and the main use pseudo historic lanterns. These were made by Edwards Lighting Engineers, a foundry in Ballart and would probably date from the 1970s. The fittings have obscure glass and low colour rendering, high pressure sodium lamps. The fittings are glaring and inefficient because the majority of the light goes into the sky. These fittings would not meet the upward light limitations of AS/NZS1158.

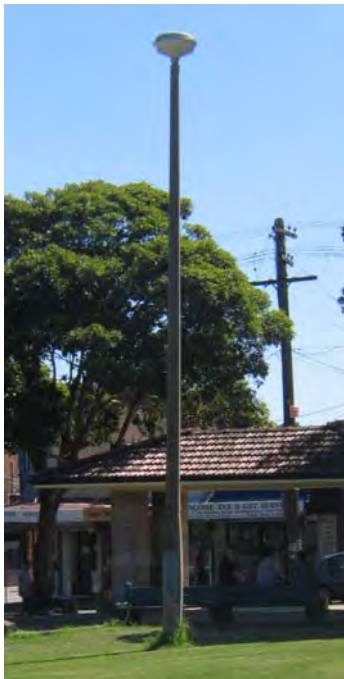
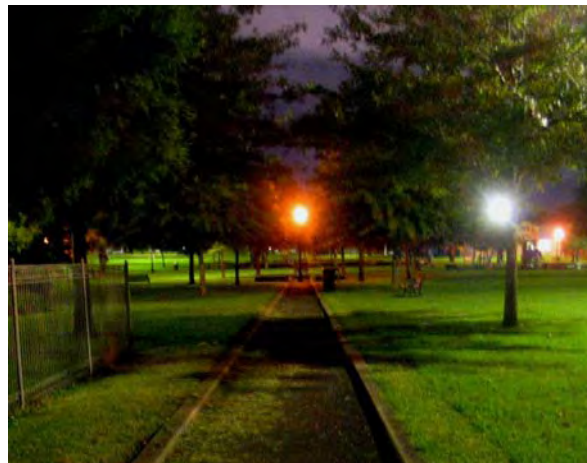
Because the lights are away from the paths and relatively high they actually cast shadows on the paths so that some of the sections of path were the darkest part of the park. The lighting increases the intensity of the shadows in the paths.

There are a number of high mast fittings throughout the park. These are GEC 'Parkway' fittings and have been a relatively standard fitting used by EnergyAustralia to light parks.

The fittings are generally scattered through the open grass and do not follow the paths. The fittings are typically around 8 metres high and use mercury vapour lamps. Although they have a solid top to limit the spill light into the sky they have very little optical control. As a result only around 20% of the light reaches the ground. In addition the mercury vapour lamps are poor colour rendering and are one of the least efficient lamps on the market today. They have effectively been banned by the Building Code of Australia for the external lighting of buildings.
